Past Years "HighLights"
of DESY RF- Group

Past Years "HighLights"
of DESY RF - Group

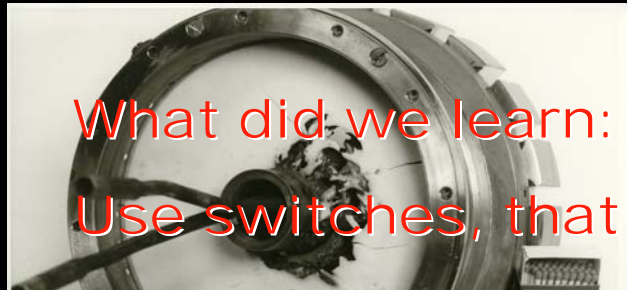
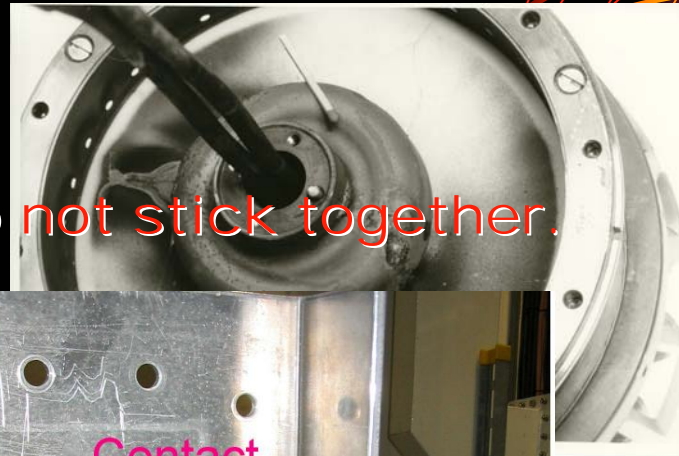
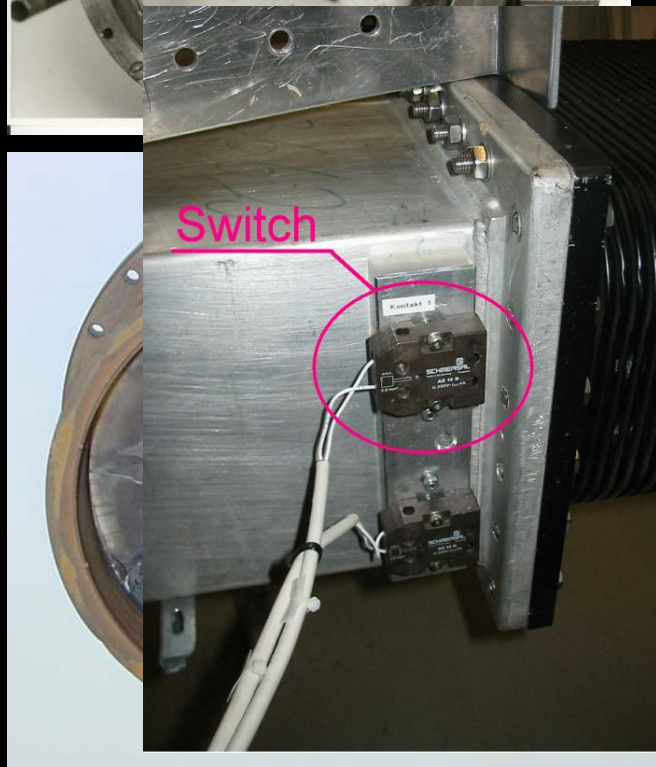
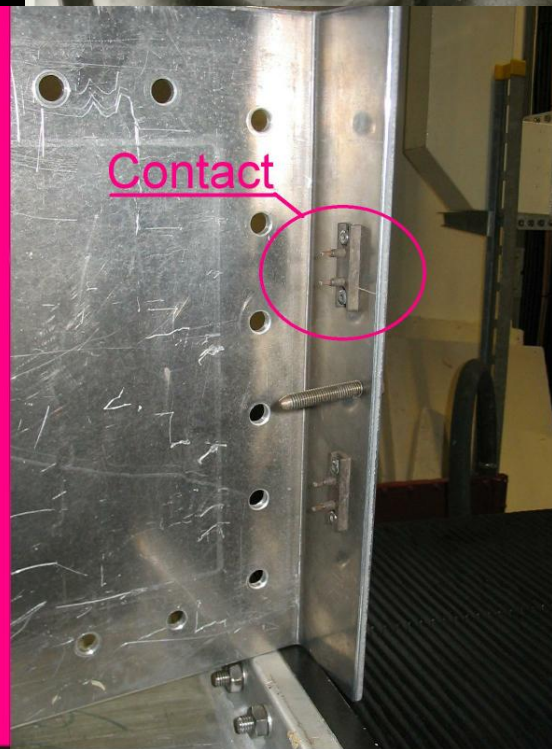
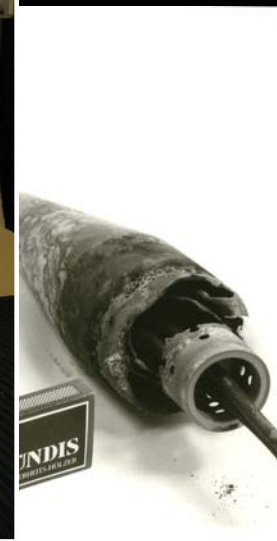
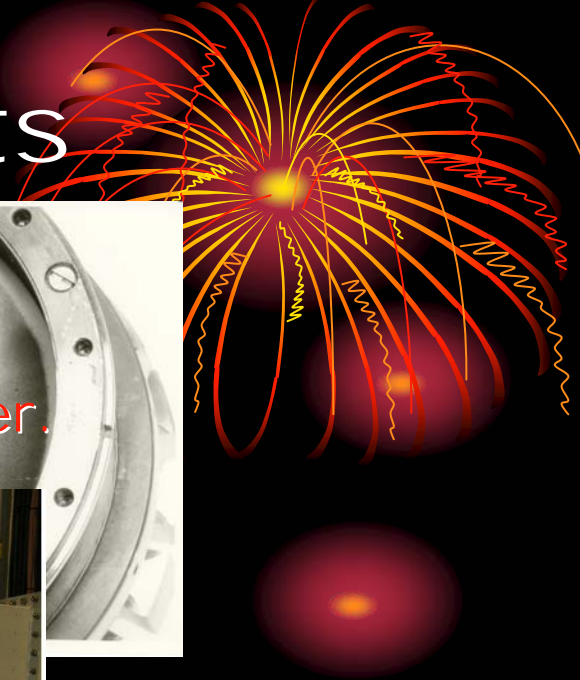
Bad interlock contacts on WG shorting plate (1988)

We have a „shorting plate“ in our waveguide system to operate the Transmitter without the cavities.

In „short operation“ the cavity interlock is deactivated (done by a micro switch)

After a “shut down” this micro switch had permanent contact.

☞ Cavity conditioning without cavity interlock!!

What did we learn:
Use switches, that do not stick together.

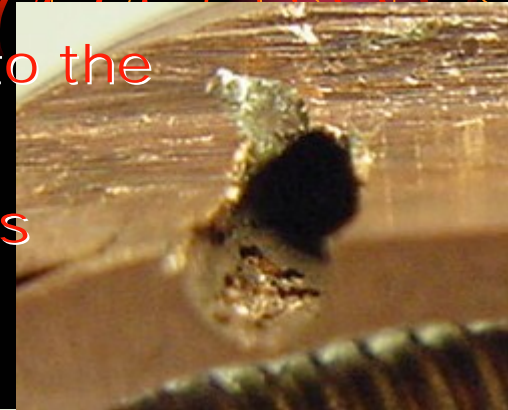
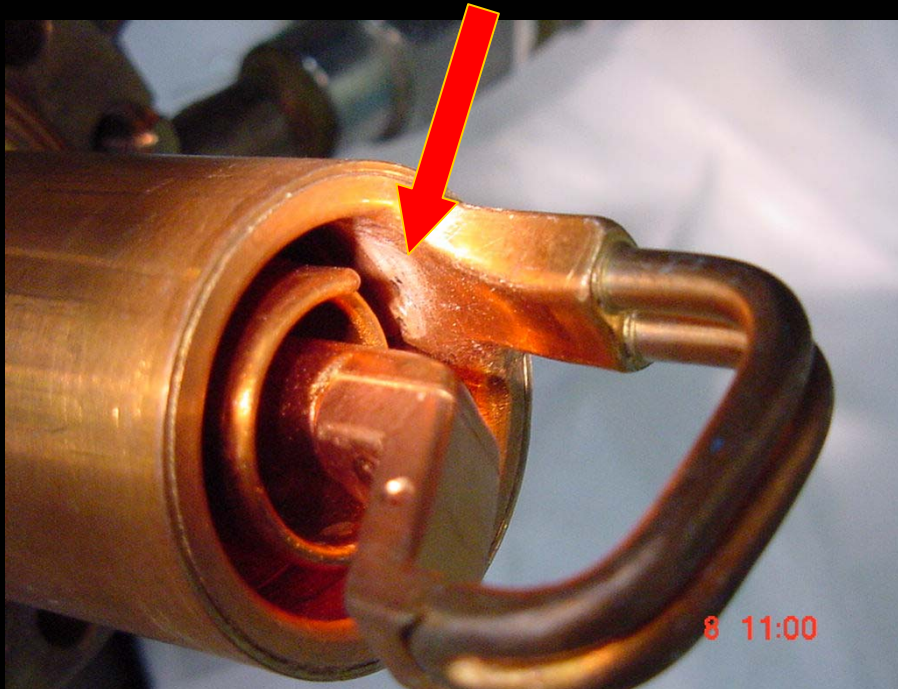
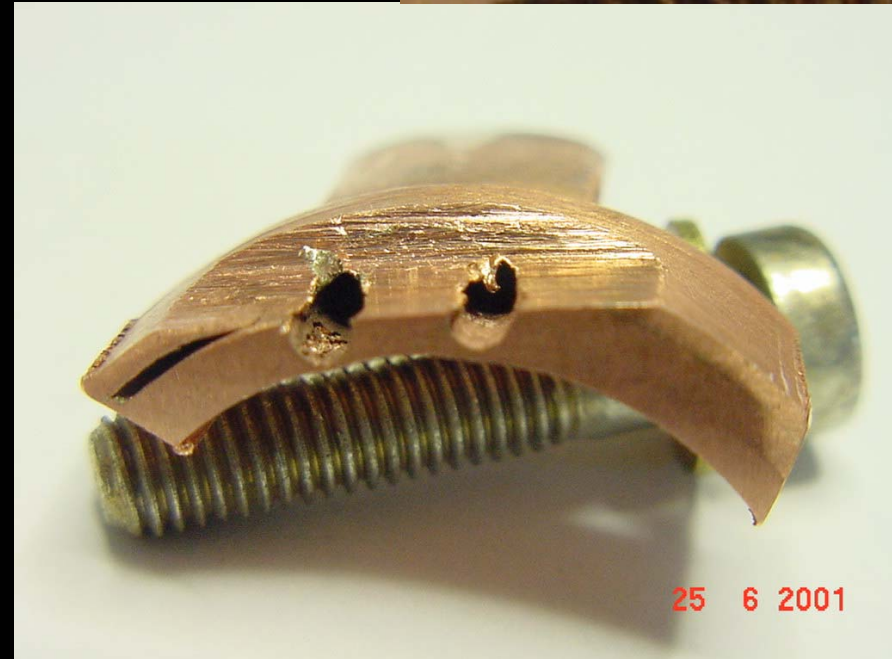
- April 23, 2001
 - DORIS Cavity 4.1
- What did we learn:

After some years of operation we had a very small water leakage in the DORIS RF- section (2001)

- Avoid installing water-cooled parts into the vacuum system
 - leakage between water system and vacuum at the inductive HOM-coupler
 - antennas in operation for 15 years
 - the water had rinsed big craters in the copper
 - sooner or later all of them would leak
 - removed all of the from DORIS
- If necessary keep the walls as thick as possible.

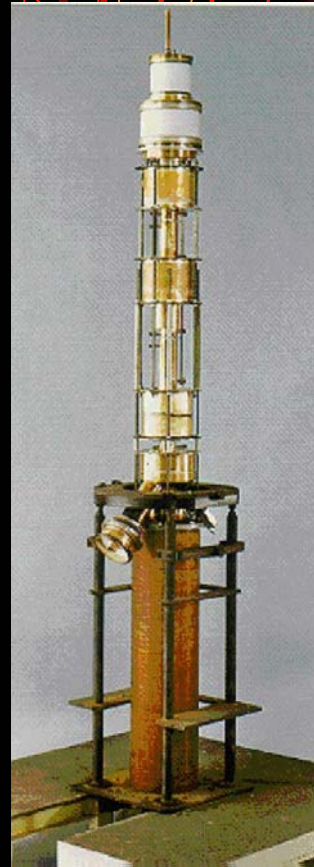
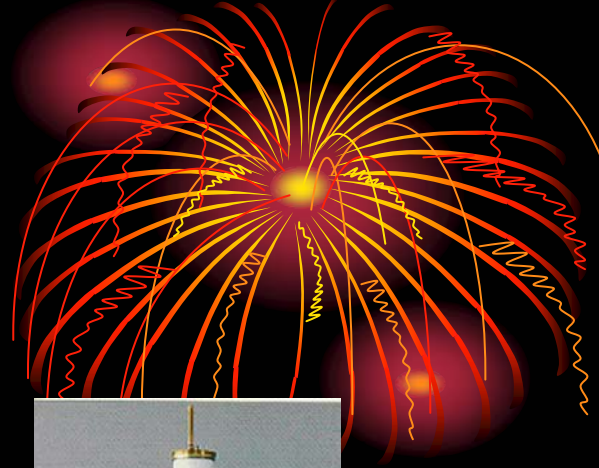
- If the focus trips
- the interlock fails
- Some racks have no power

then the beam
melts a hole in
the collector
and...

Design the interlock (contacts) power
fail save

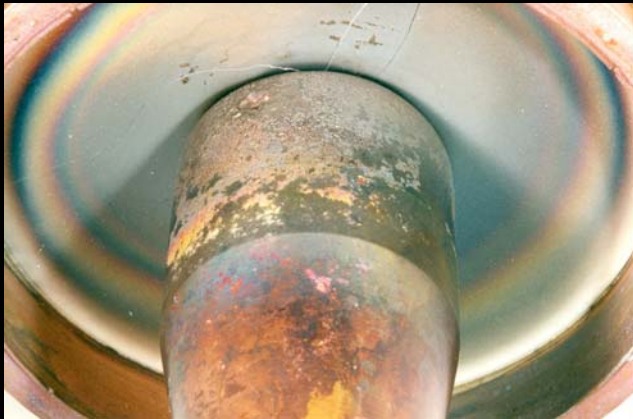
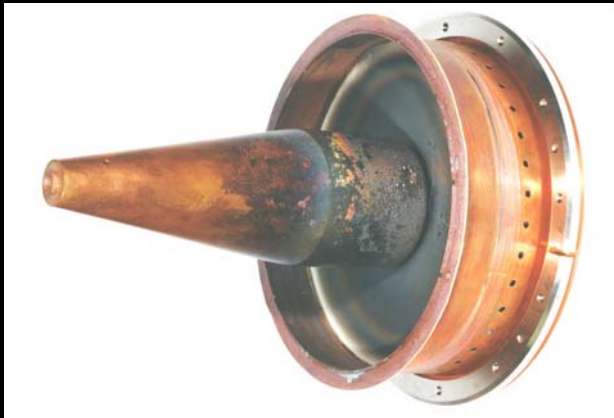
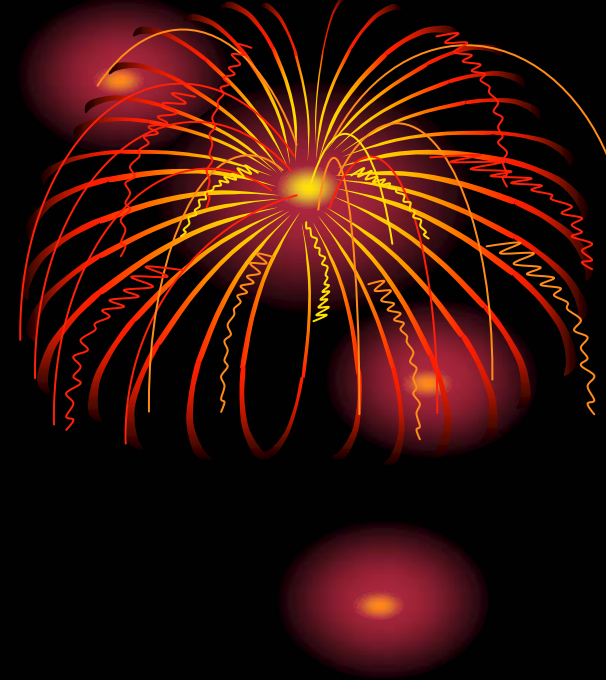
Pictures

- Commissioning of cavities
- Interlock failure
- Vacuum measurement failure
- Misinterpreting
- Interlock jumpered at the wrong place
- Full power on "not conditioned cavities"
- Sparking on Coupler without rf switch off
- ☠ 12 Input coupler broke ☠

- Interlock jumpering only by EXPERTS
- Test the interlock before switch on

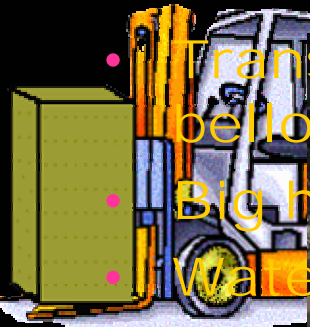
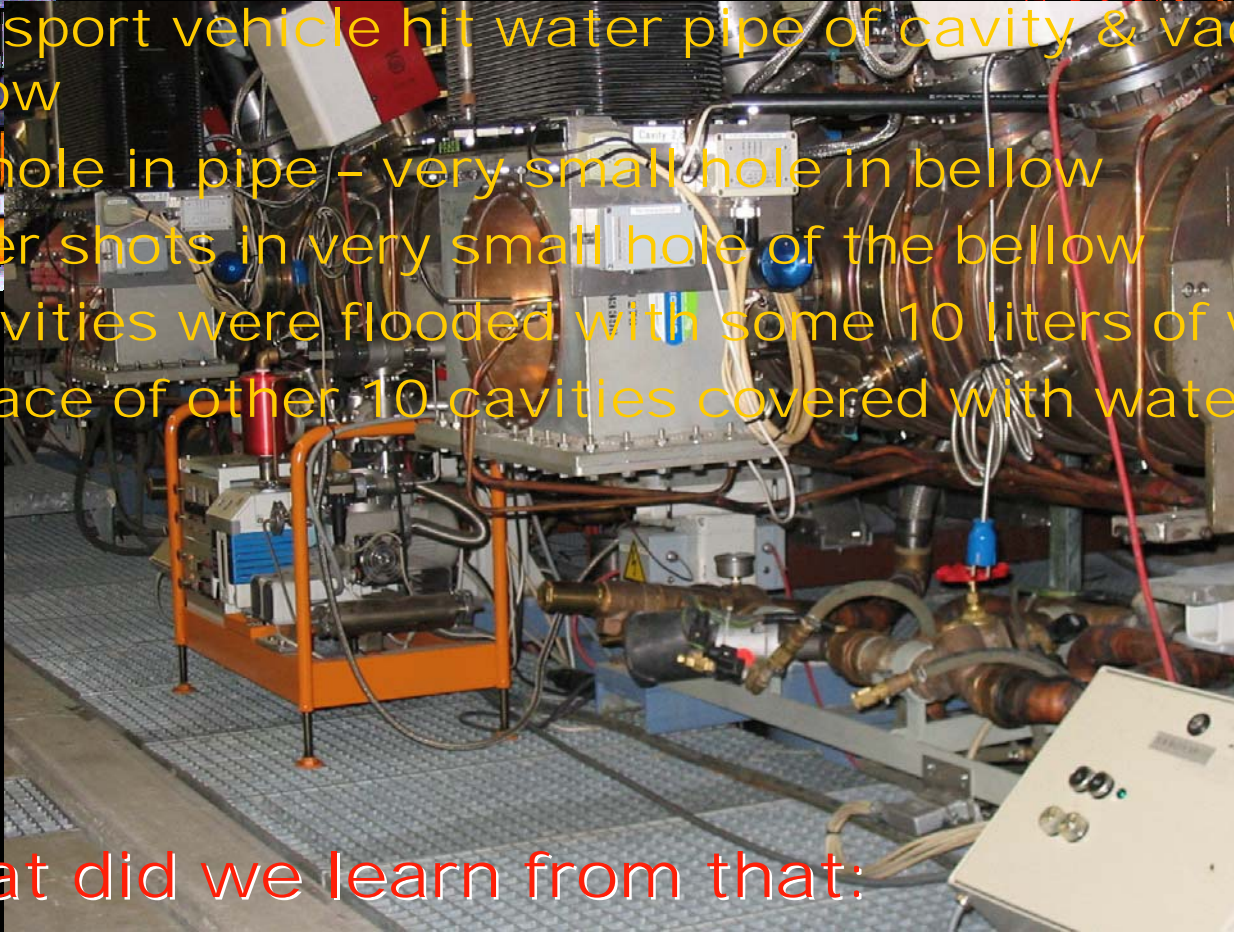
- Transport vehicle hit water pipe of cavity & vacuum-bellow
- Big hole in pipe - very small hole in bellow
- Water shots in very small hole of the bellow
- 2 Cavities were flooded with some 10 liters of water
- Surface of other 10 cavities covered with water drops

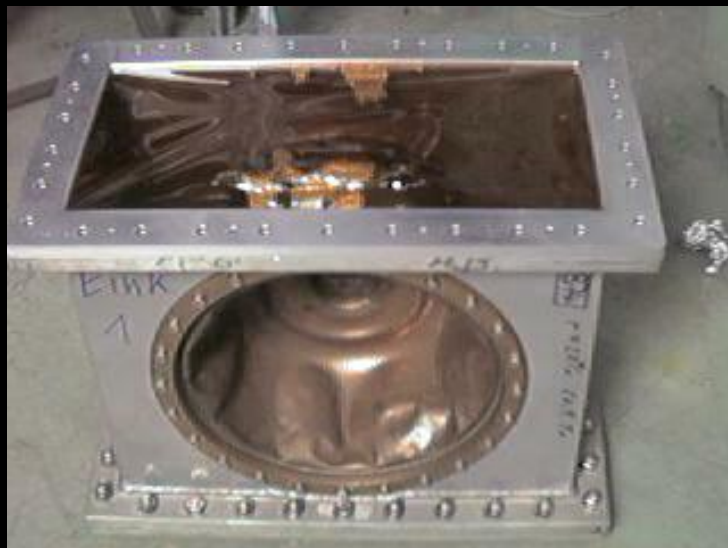
- We shutted the WG to keep the forced air in the coupler area
- There was a spark on the air- flow- side of the input coupler

The spark produced a pressure- wave, that deformed the doorknob

What did we learn from that:
No capton foils to close to
"sparking risk" areas

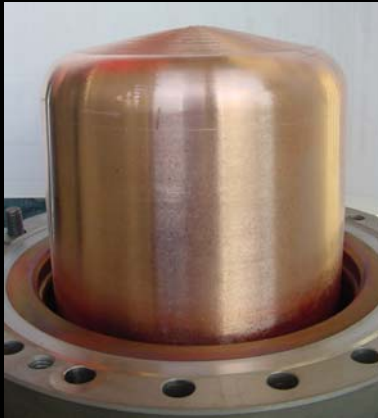
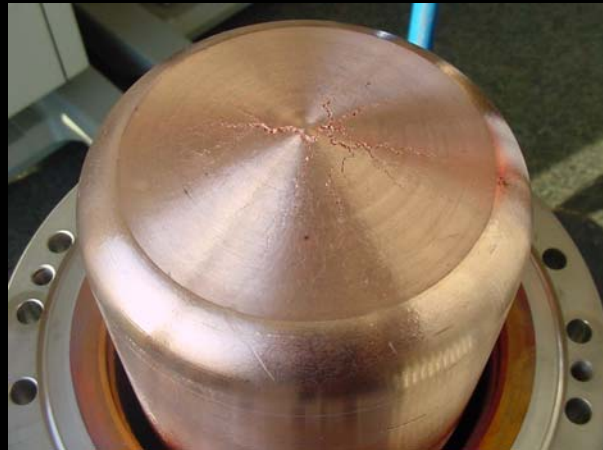
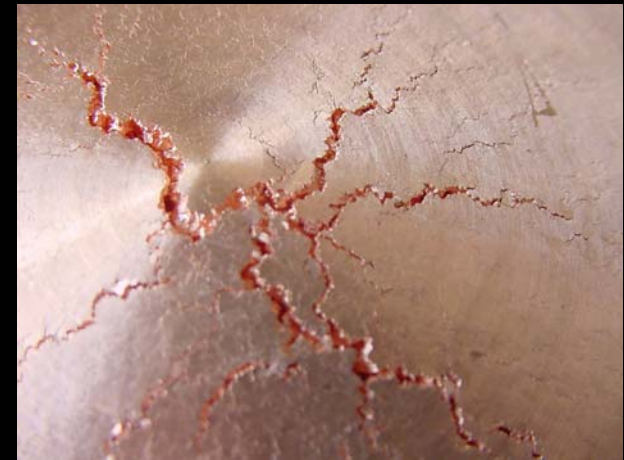
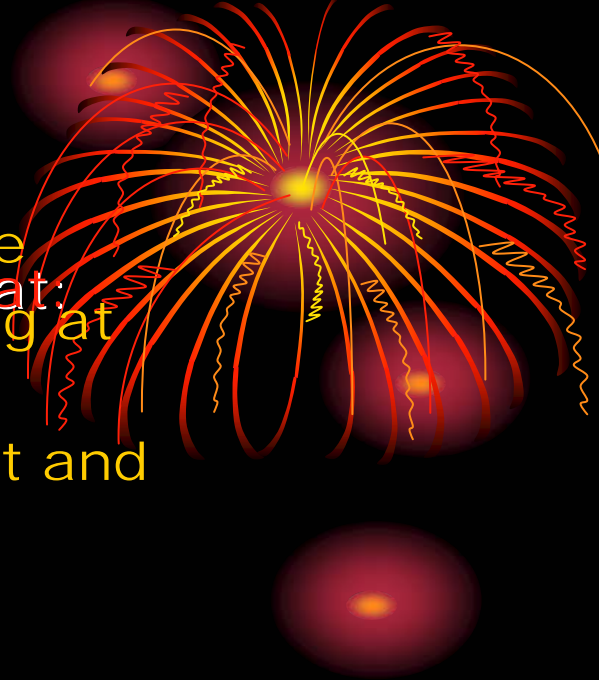
.. and for some reason we had to decrease the water flow (*seems to be no problem – deposited power is small*)

Air -bubbles move
to the top of a device
What did we learn from that:
So there is no cooling at
Keep the water flow big
enough, that there are no
bubbles in the system
all
The plunger get's hot and
looks like

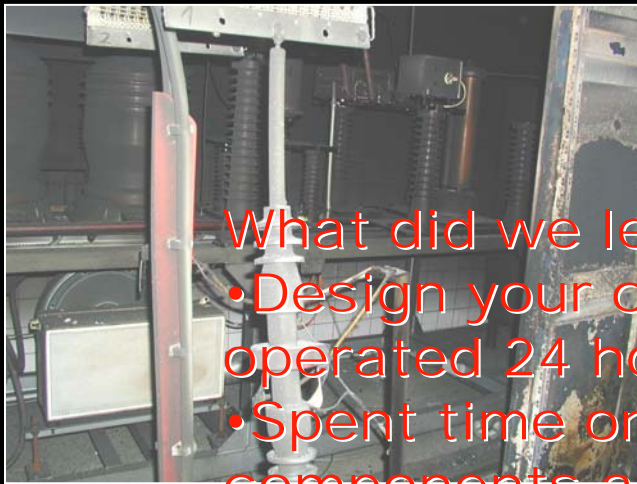
- Crowbar has hv-supply for initial spark
- Discharge-resistor went hot and damaged hv capacitor
- Leakage current
- Heat, fire

- What did we learn from that:
 - Design your components to be operated 24 hours / 7days
 - Spent time on inspections of your components at regular intervals
