ANKA RF Status

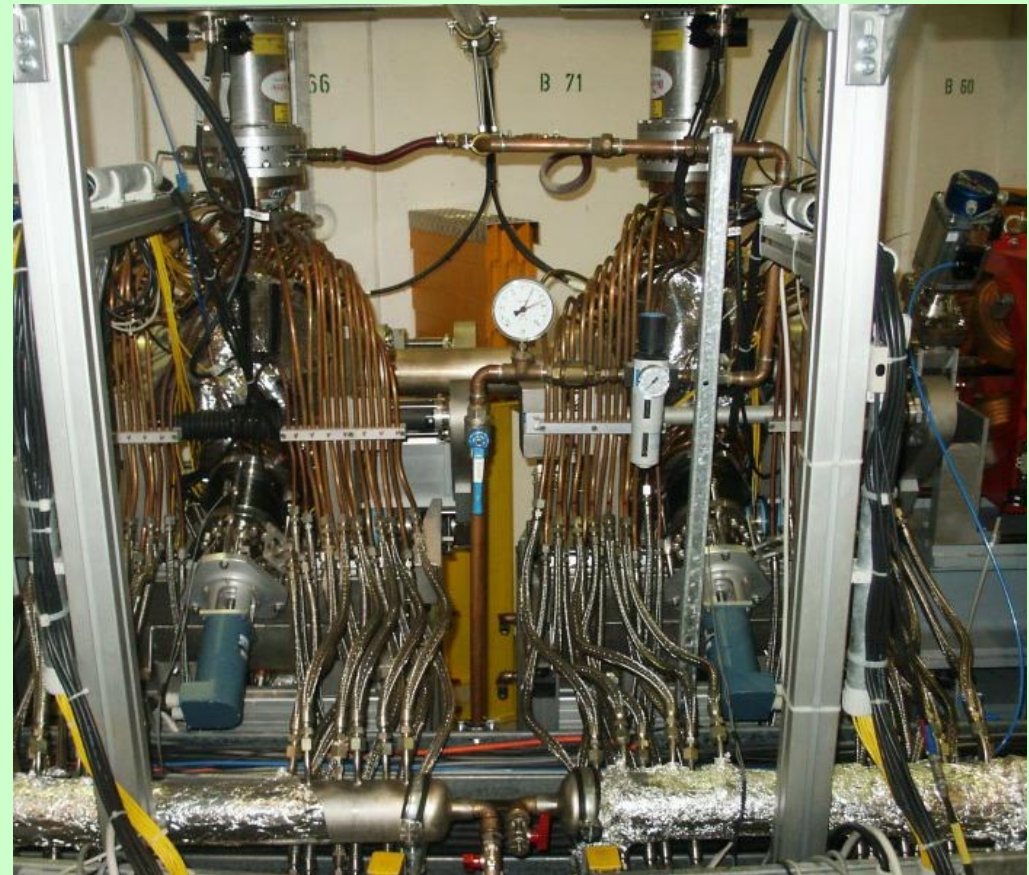
Cavity Cooling

Some rubber tubes leaked
All rubber tubes replaced by
Stainless steel tubes

Sealing of all cooling pumps
had to be replaced
