Status of the Diamond Storage Ring RF Systems

Morten Jensen
on behalf of
Diamond Storage Ring RF Group

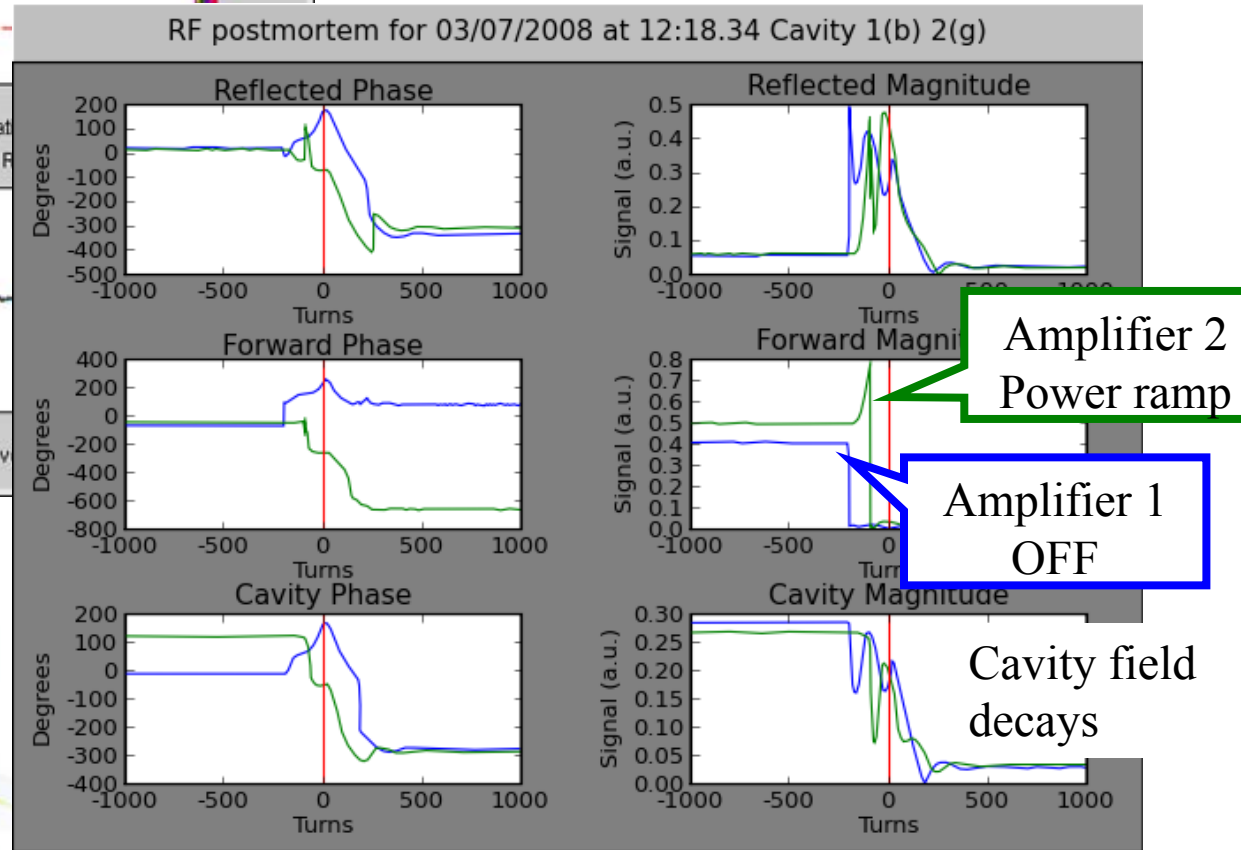
Beam spirals
in on loss of
RF

Beam lost

Amplifier 1 IOT trip with stored beam
System 2 follows on MPS.
Note increase in power on system 2 as
system 1 is tripped. Beam 178 mA

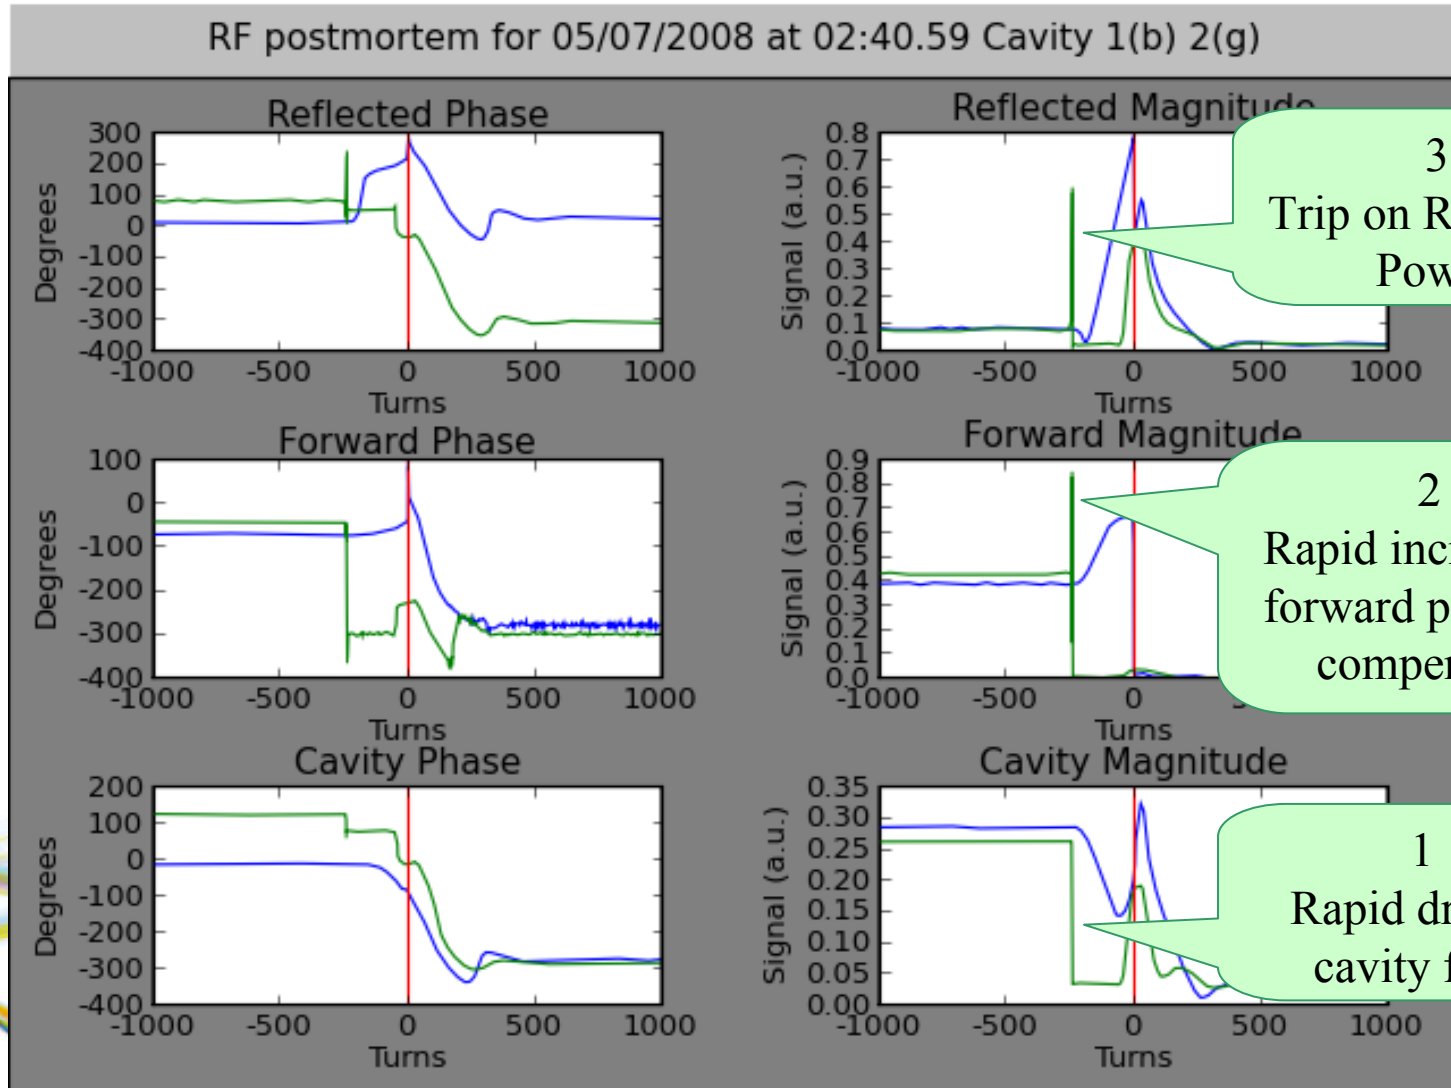
Fast Cavity Trip

IOT Short Circuit indicating HV breakdown

Cavity field collapses in 2-3 turns
→ no longer a high Q cavity

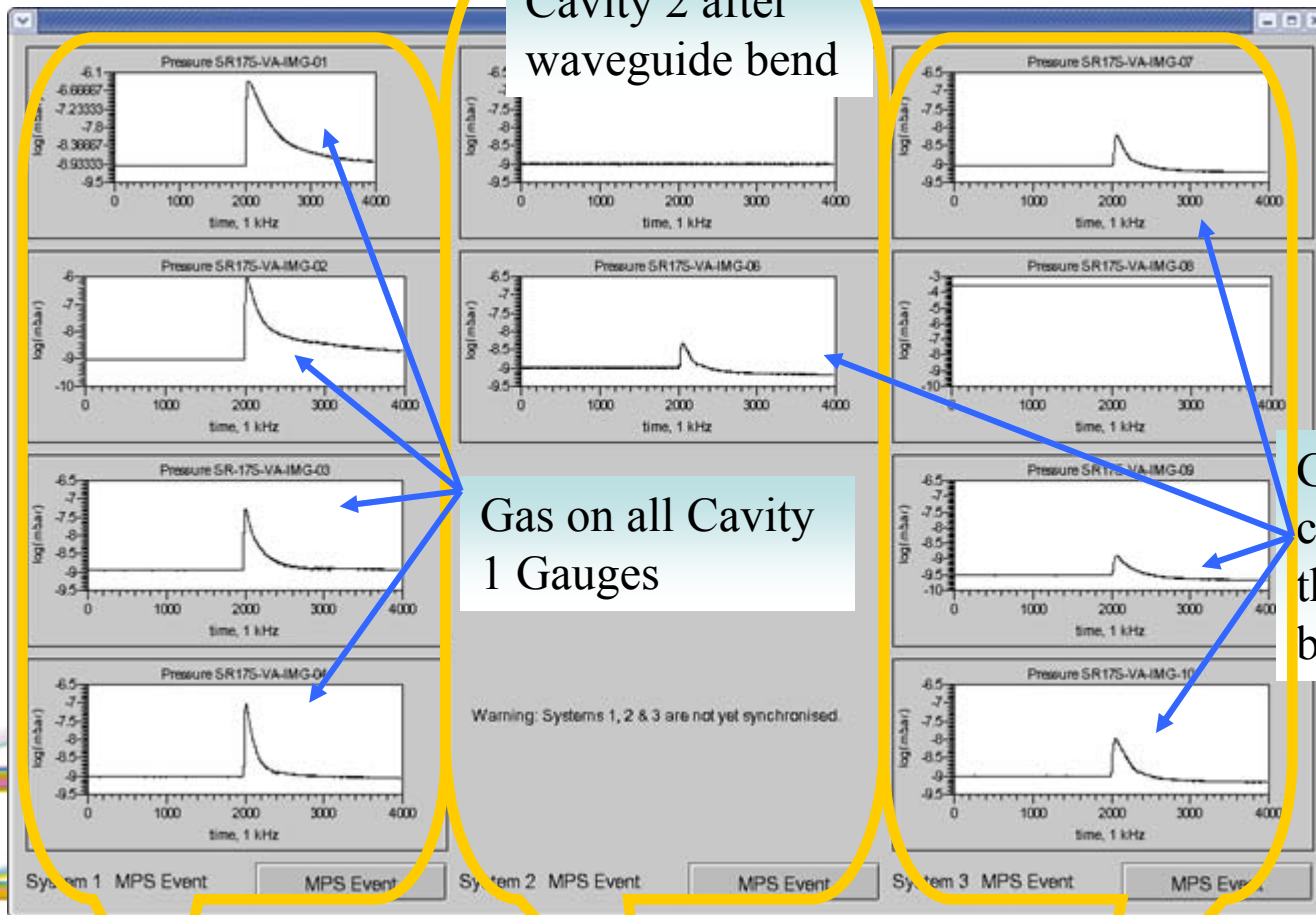
Synchronised Fast Vacuum Data Acquisition Cavity 1 trip

Cavity 2 after waveguide bend

Gas on all Cavity 1 Gauges

Gas travels through the cavities but not around the cold waveguide bend

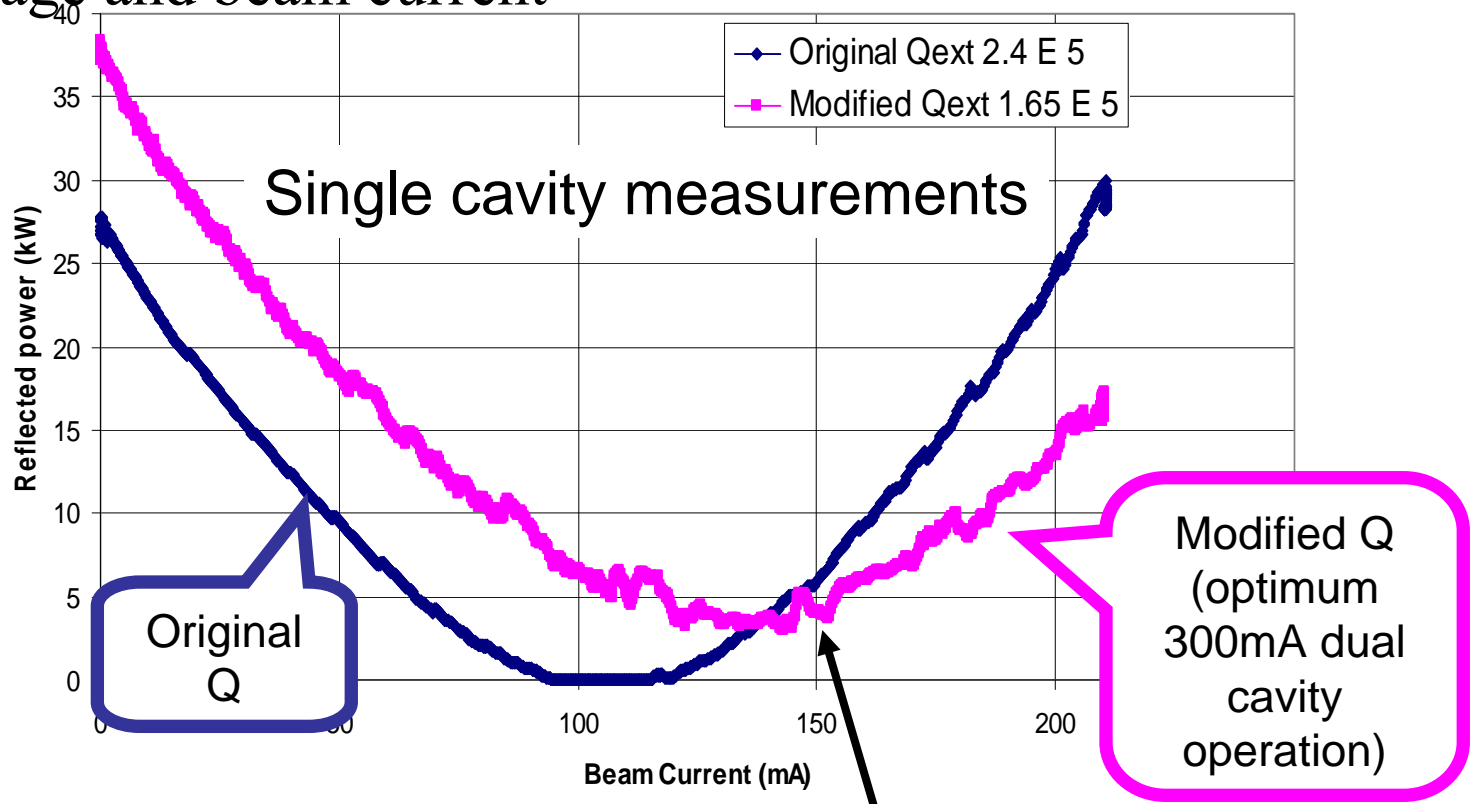
Qext is modified by installation of a 3-stub tuner between the circulator and the cavity coupler
→ Qext can be adjusted for particular operational parameters i.e. voltage and beam current

Non zero reflected power due to the cavity being slightly off resonance

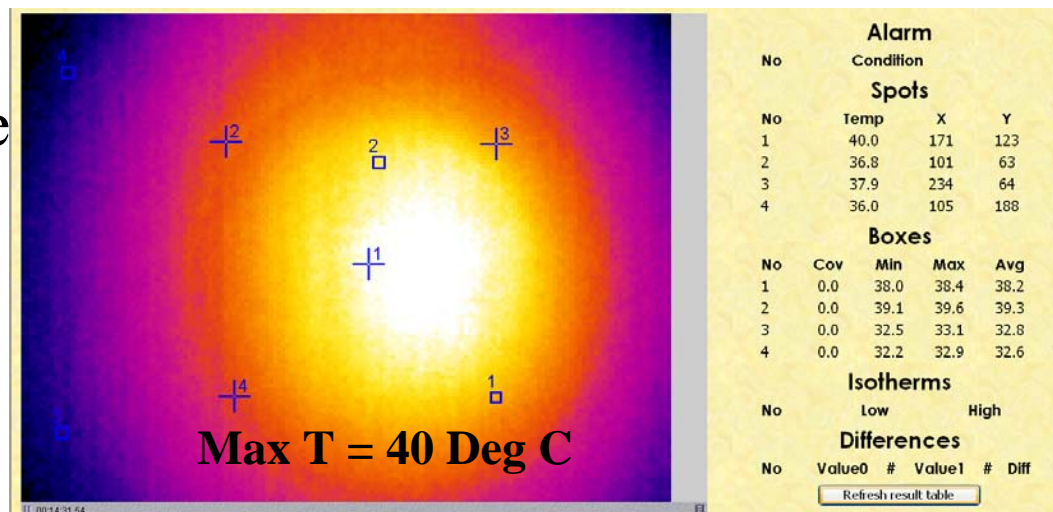
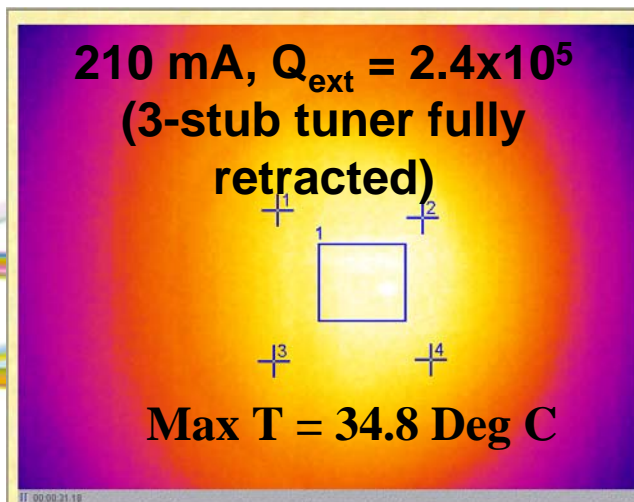
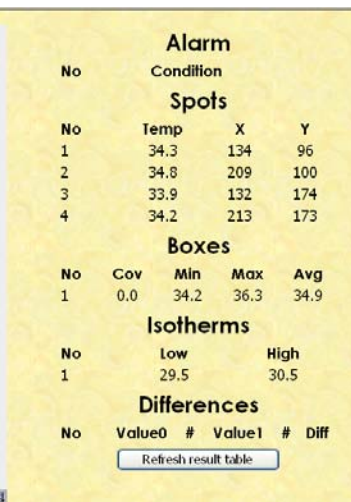
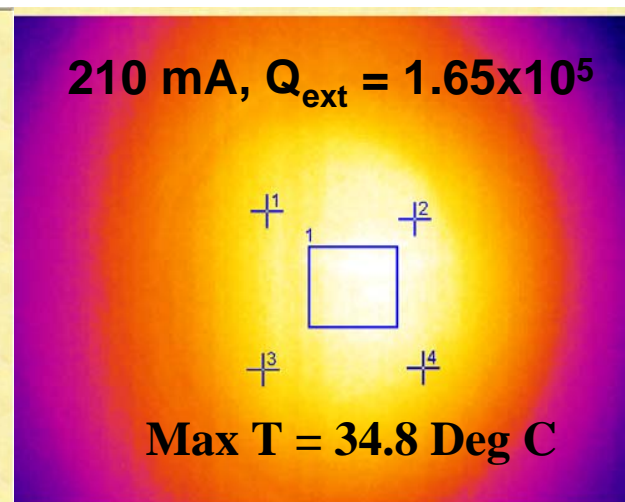
Thermal Plots of Window Temperature Distribution

3-stub tuner = Standing Wave
How great is the risk?

No beam
104kw at - 40deg
off resonance
