Status of RF Group HZB

(former BESSY)

Wolfgang Anders

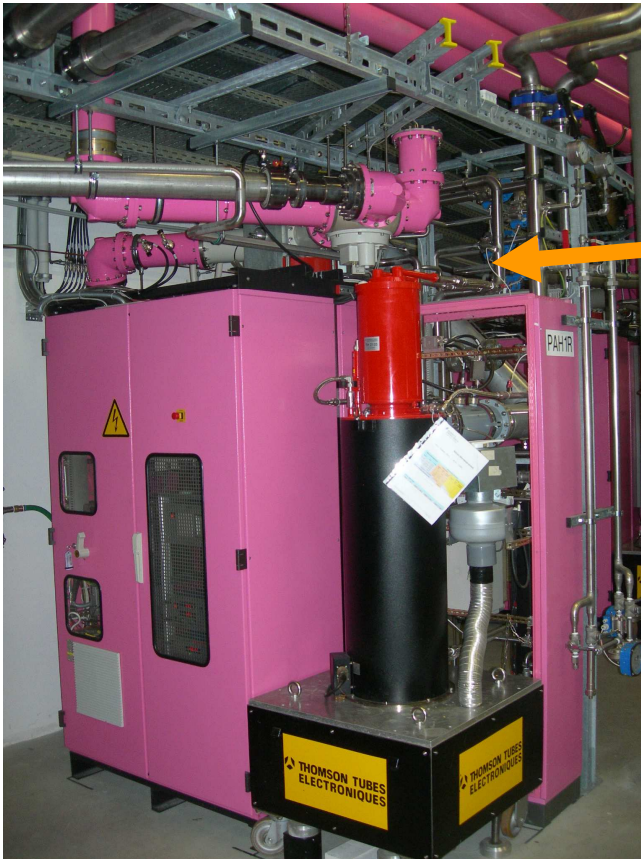
80.000 h klystrons

3 of 4 klystrons at BESSY II have
operating time of ~ 80.000 h now

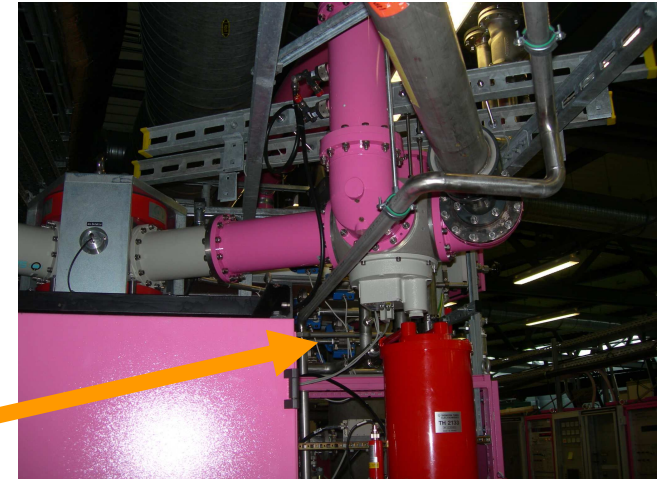
Coaxial switch at
the 75 kW RF line

To be prepared in case of
problems, we install a high
power coaxial switch with load at
each transmitter.

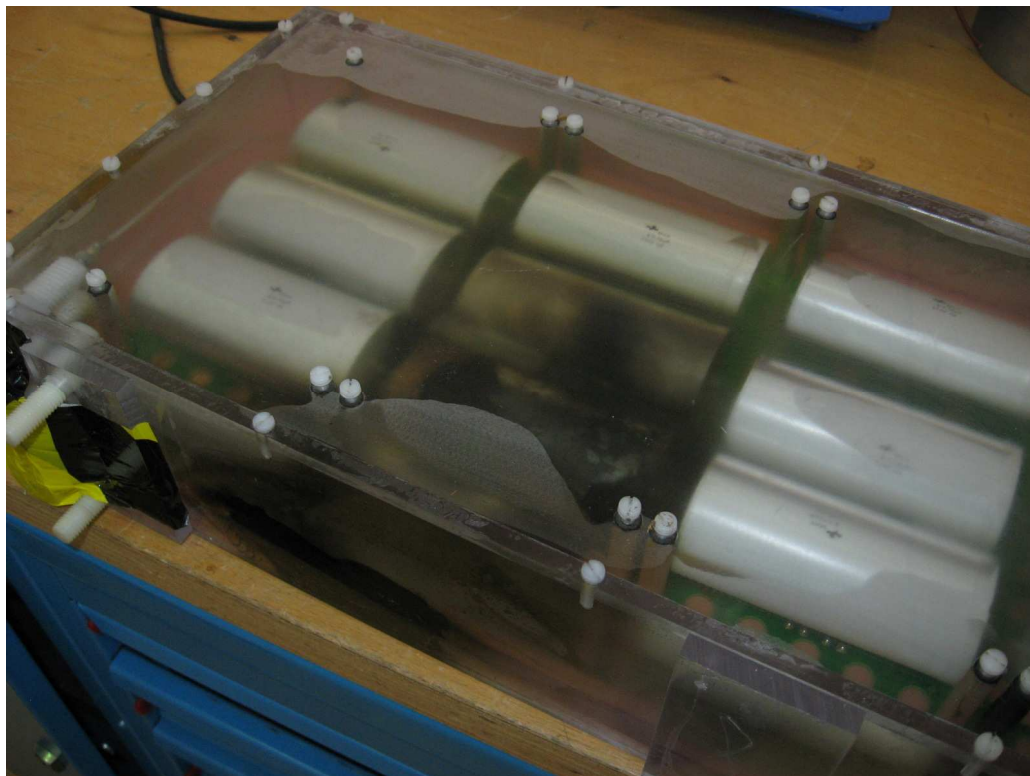
HV PS defekts

Burned part in HV PS

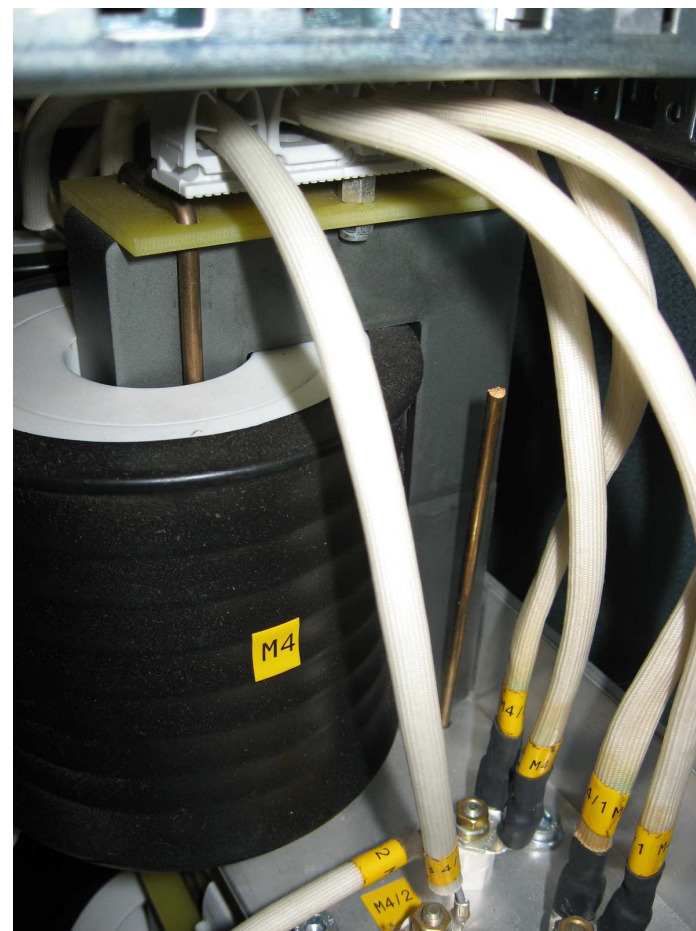
**Broken brass rod at
HV transformer**

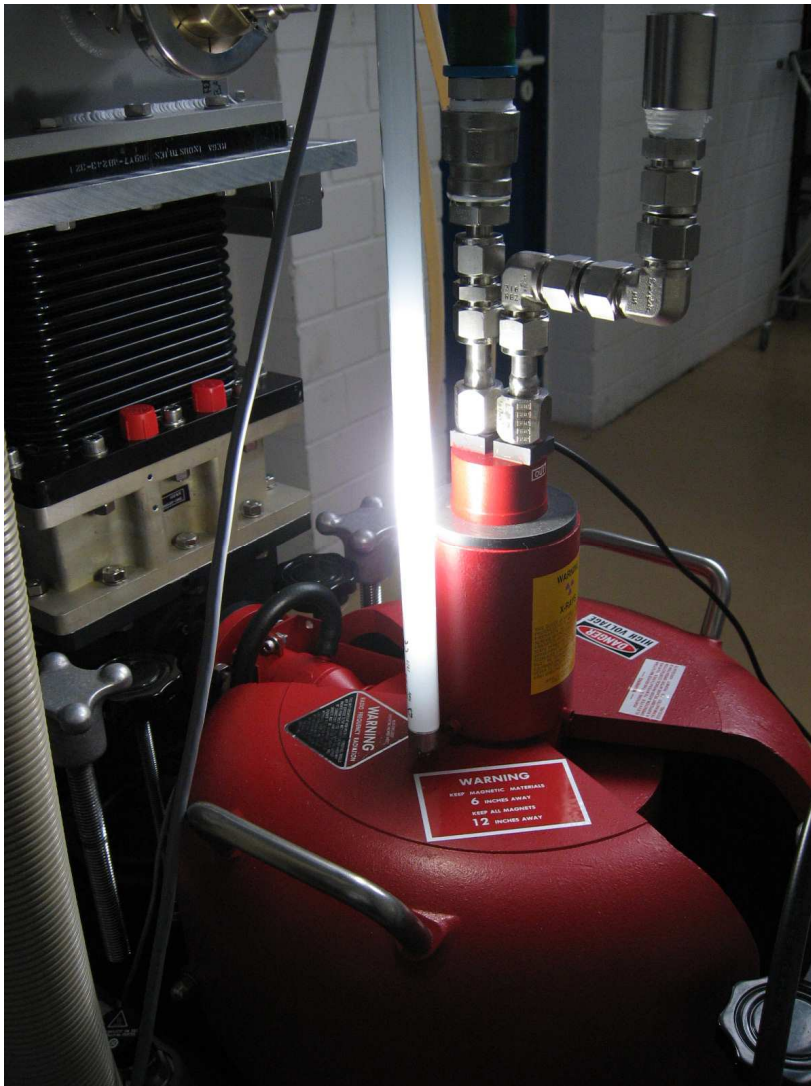
Curios: energy saving lamp

RF leakage at 10 kW 1.3 GHz klystron

→ Operating a neon lamp „without energy“
at RF field of 15 V/m in air
