RF Status of ALBA

Angela Salom on behalf of RF team: Francis Perez, Bea Bravo and Jesus Ocampo

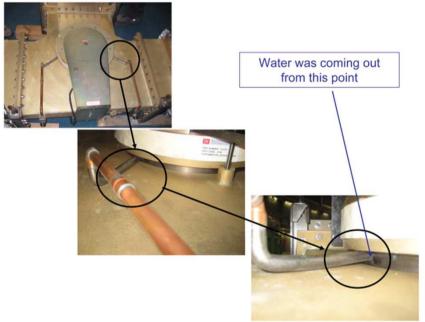
- 2 circulators got broken
 - First one: Water leak in c
 - Second one: short-circuit
- 2 Brand New IOTs got broke the ceramic. Thales providec

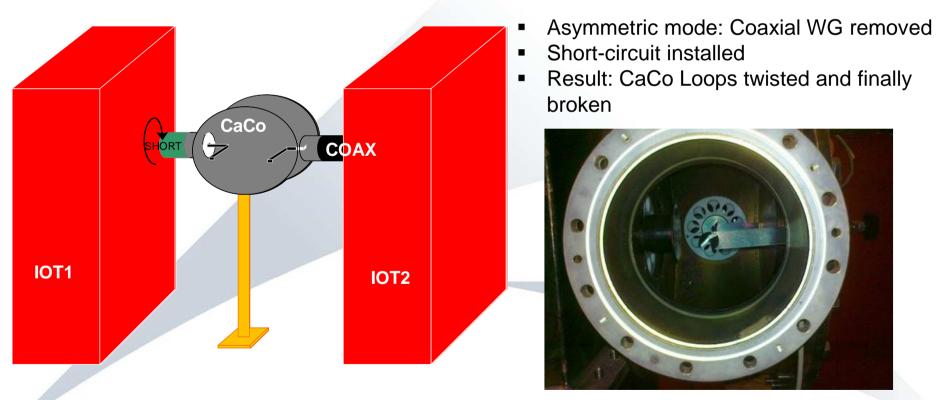
- During Spring Shutdown: Loops of CaCo got broken when installing short-circuit
 - CaCo Symmetric mode: Combines power of two IOTs
 - CaCo Asymmetric mode: one IOT is switched off while 2nd IOT is active

All loops of CaCo had to be reviewed and replaced during summer shutdown

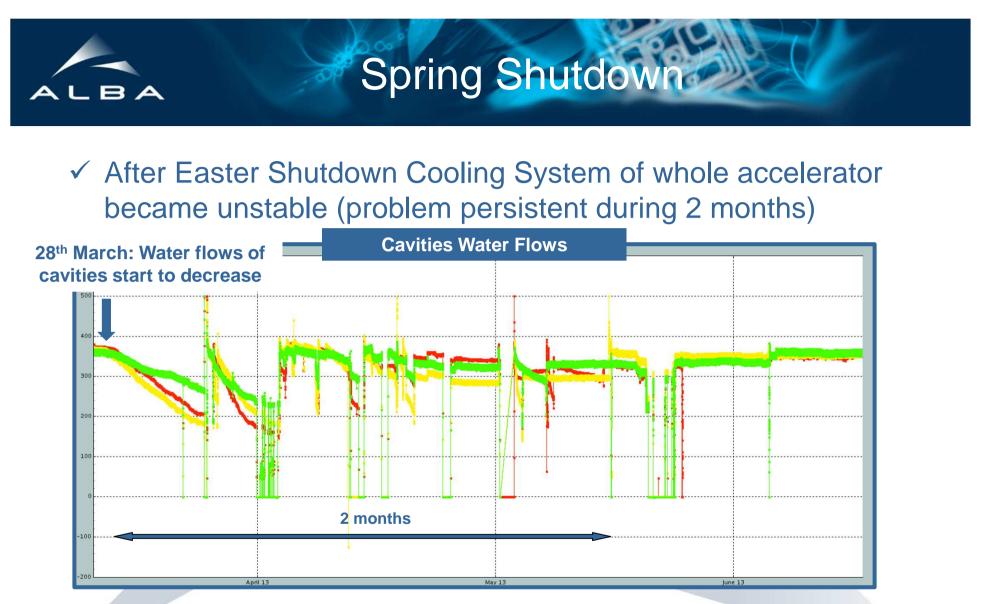
Air in the cooling system made the pressure drop steadily causing the accelerators sub-systems to trip.

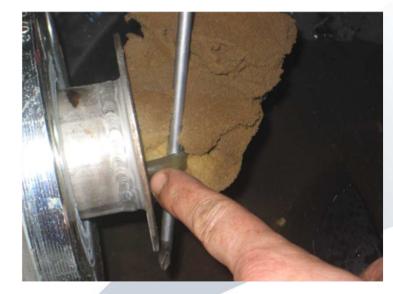
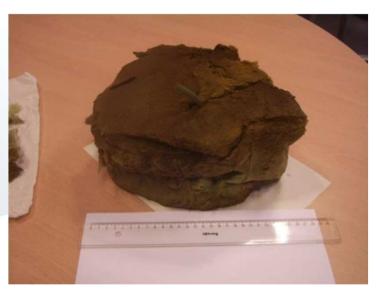
General pipes of cooling system were cleaned (sponges found in the process)

- Water pumps operation conditions changed to avoid cavitation
- Flow Control and distribution optimized
- Air purging
- Air releasers installed in whole machine

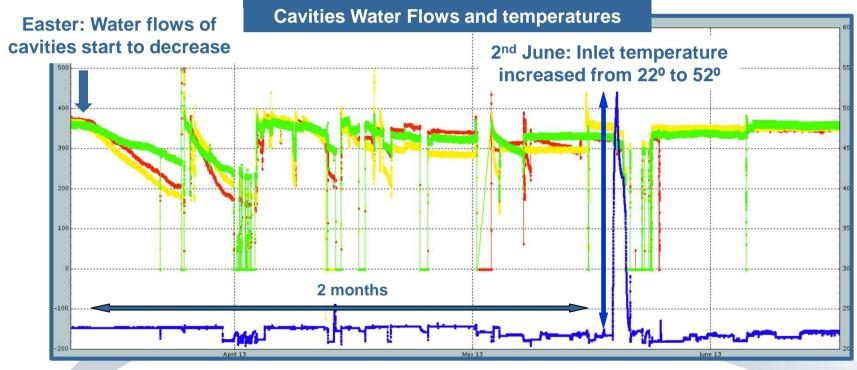
✓ After solving cooling problem, cooling control PLC misconfiguration error stopped heater exchanger operation and water temperatures rose above 50°
