# SLS RF operation report 2003

# <u>M. Pedrozzi</u>, Jean-Yves Raguin Paul Scherrer Institute, 5232 Villigen PSI, Switzerland

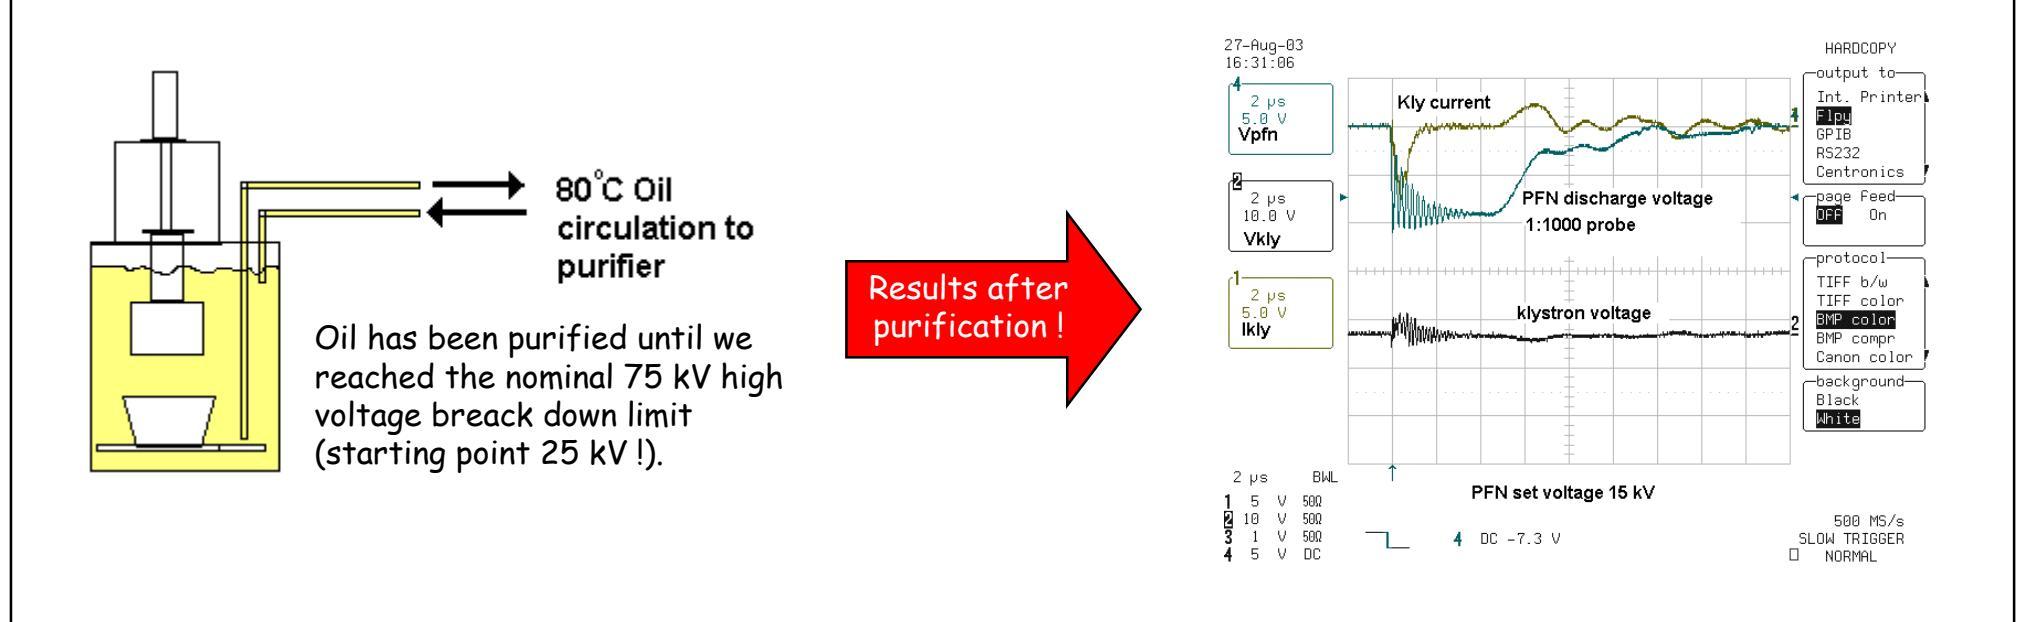
#### 1) The in situ oil regeneration (normal procedure for transformer) is here very risky.

Since in principle there is no temperature sensitive components in the tank, and after discussion with CERN, we decided to try the in situ regeneration because our oil was not anymore in production.

Consequence: We completely opened the tank and carefully inspected all components.

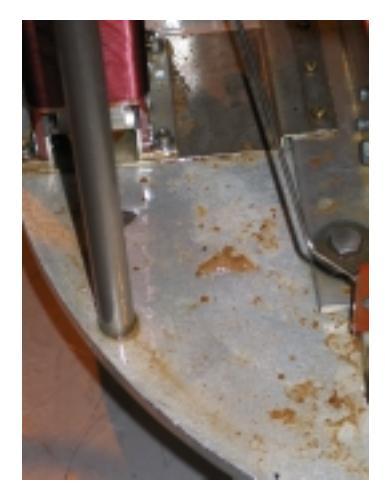
Bottom support plate

Everything was quite dirty and still an important amount of water was on the bottom of the tank, in the capacitive probe for the HV measurements, and in the cover containing the tri-axial cable connector. The current and HV probe coaxial cable was damaged, probably because of the regeneration temperature.

All components have been cleaned using alcohol.

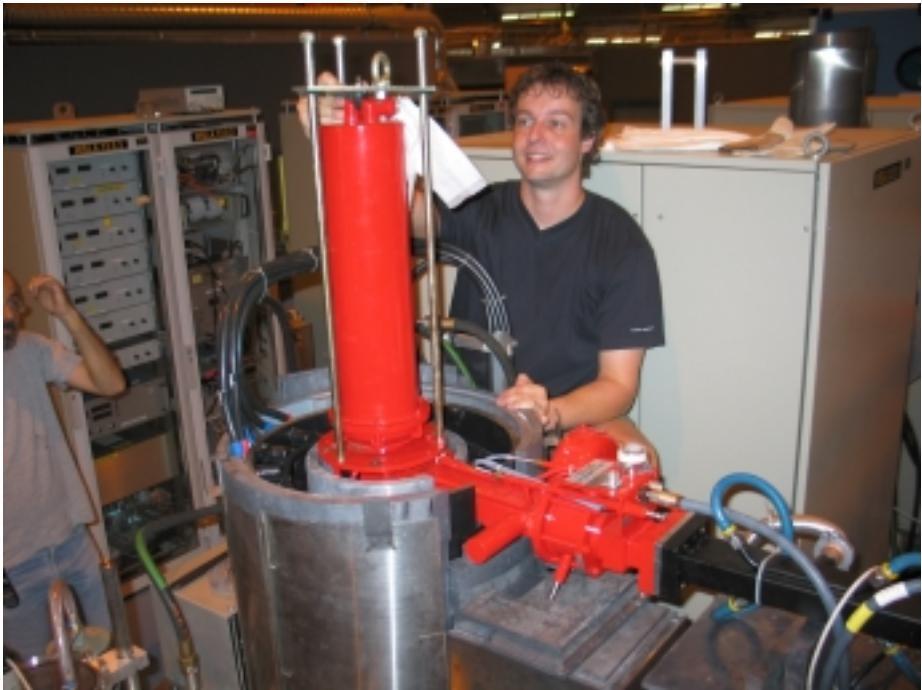
TH2100 collector

- 2) For safe operation would be a good idea to analyze the oil at least once every 6 months.
- 3) Once per Year inspect the tank components and replace the oil with fresh oil.
- 4) Oil should be regenerated only outside.
- 5) The klystron collector water connection are probably partially responsible of the oil water contamination (metallic conical fitting, very hard to get tight). We will modify the fitting to integrate an O-ring.

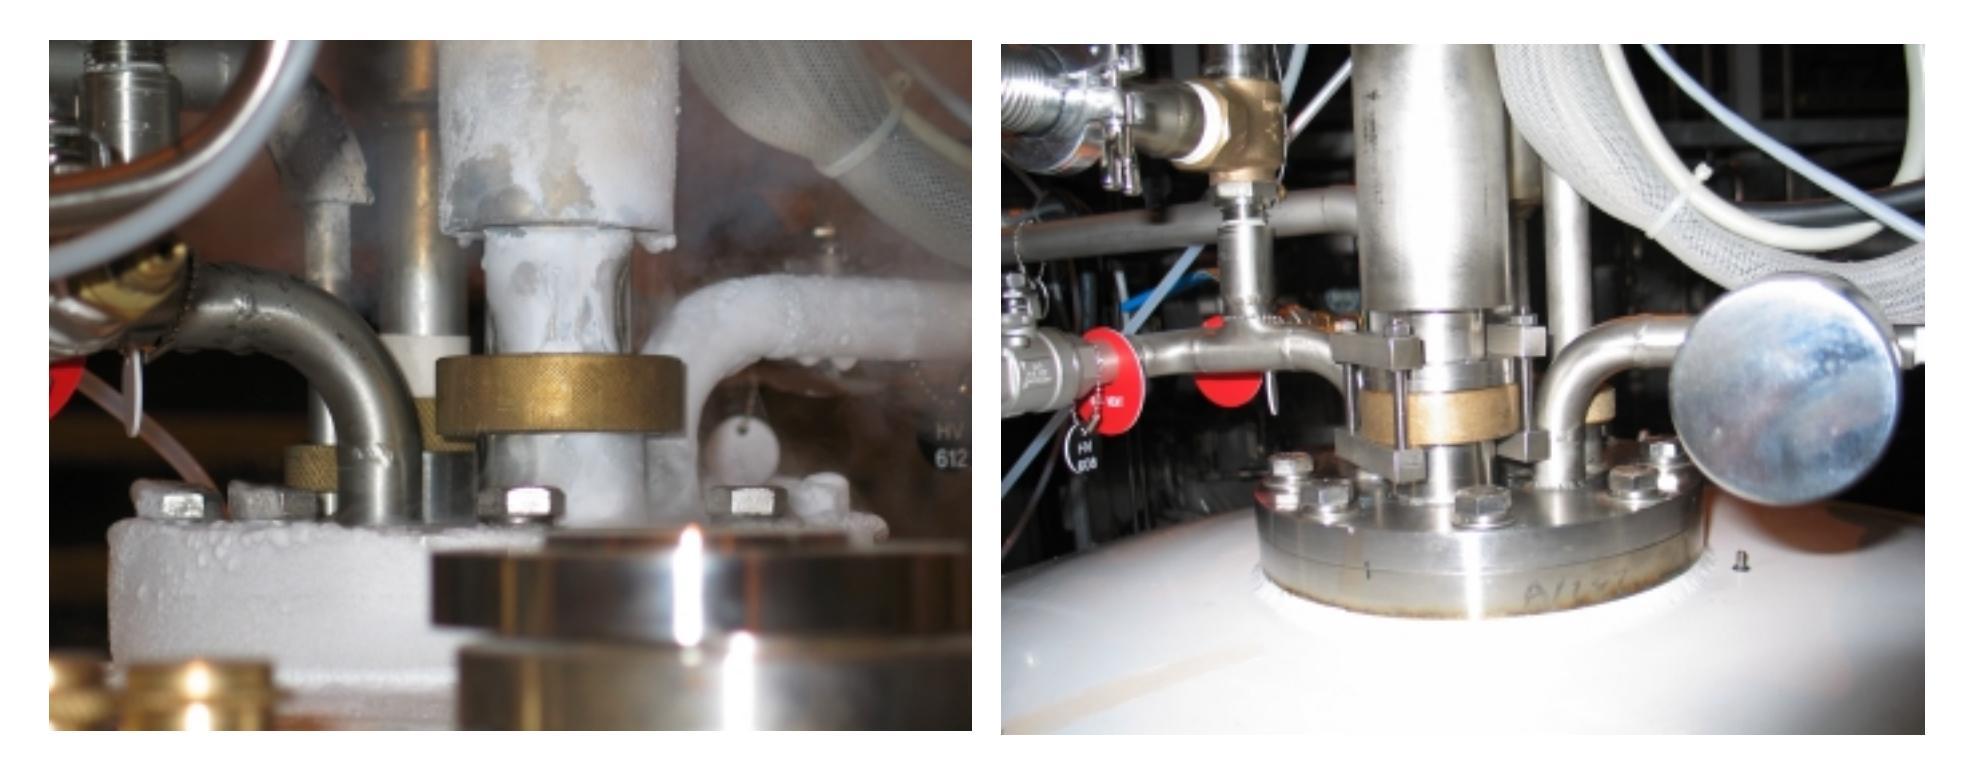
Cold Box / Dewar transfer line junction leaking probably due to the vibration induced by the insulation vacuum primary pump and/or the very high room temperature.

He leak on the Dewar

Junction consolidated with an Indium wire
