Update of the Storage Ring RF System

Morten Jensen on behalf of the Storage Ring RF Group

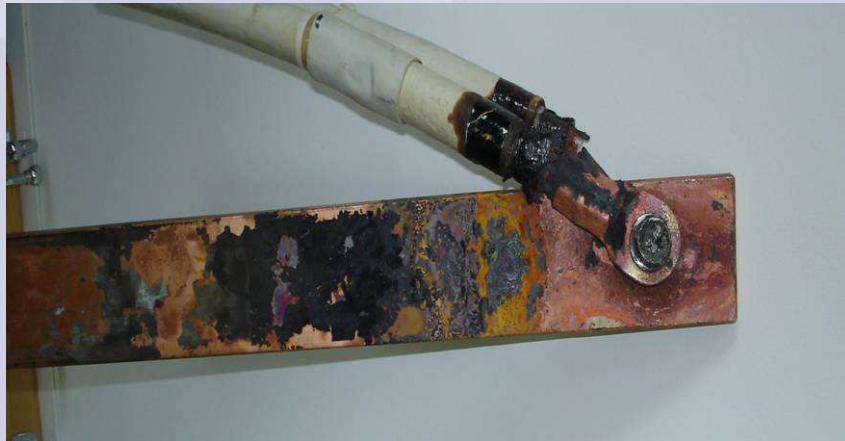
Bus bar incorrectly installed

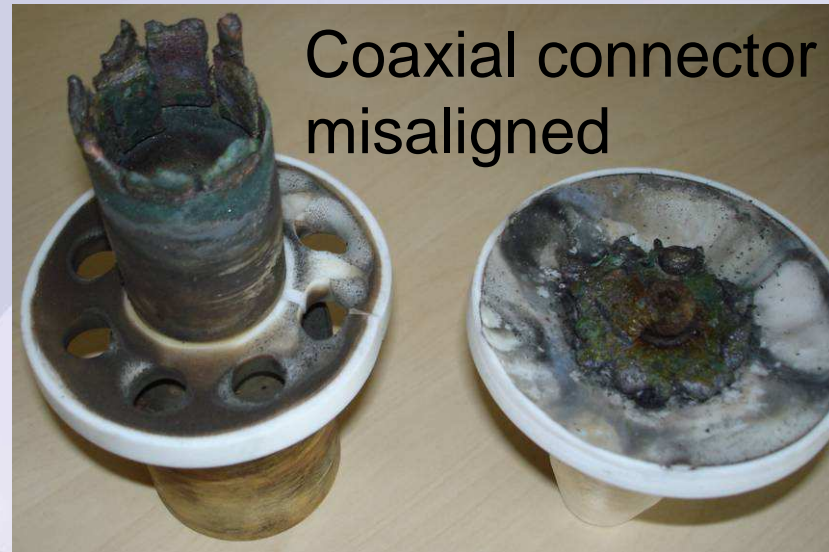
Coaxial connector
misaligned

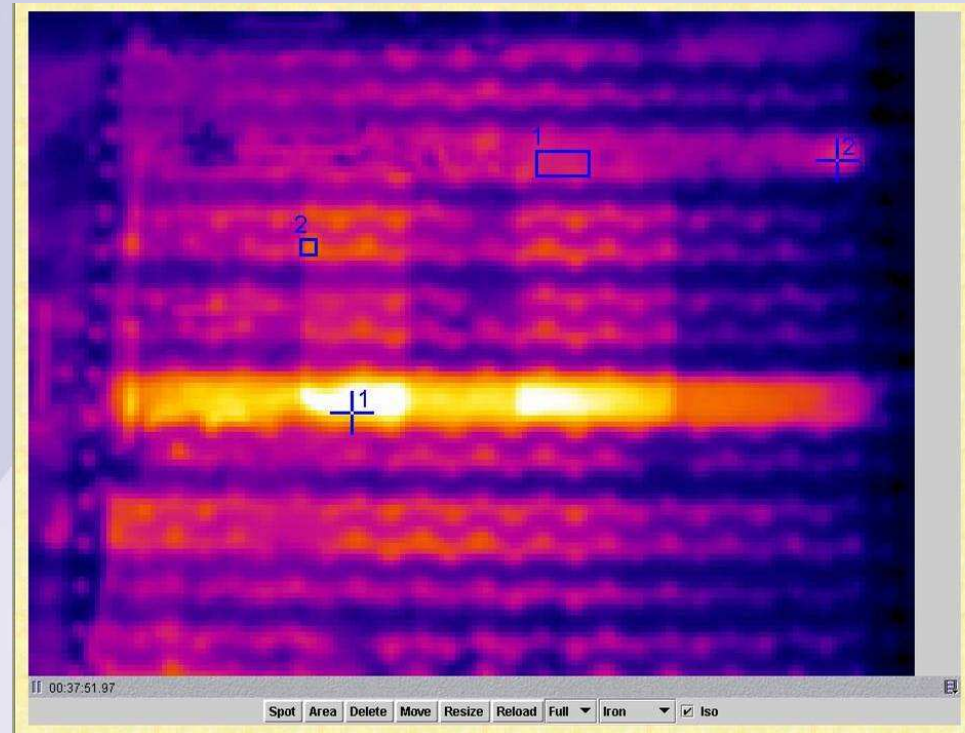
300 kW loads still trip and loose tiles.

Thermal distribution of water load indicates blocked channel

One load returned to AFT for repair.

Two sections to be replaced for lower loss and further section added

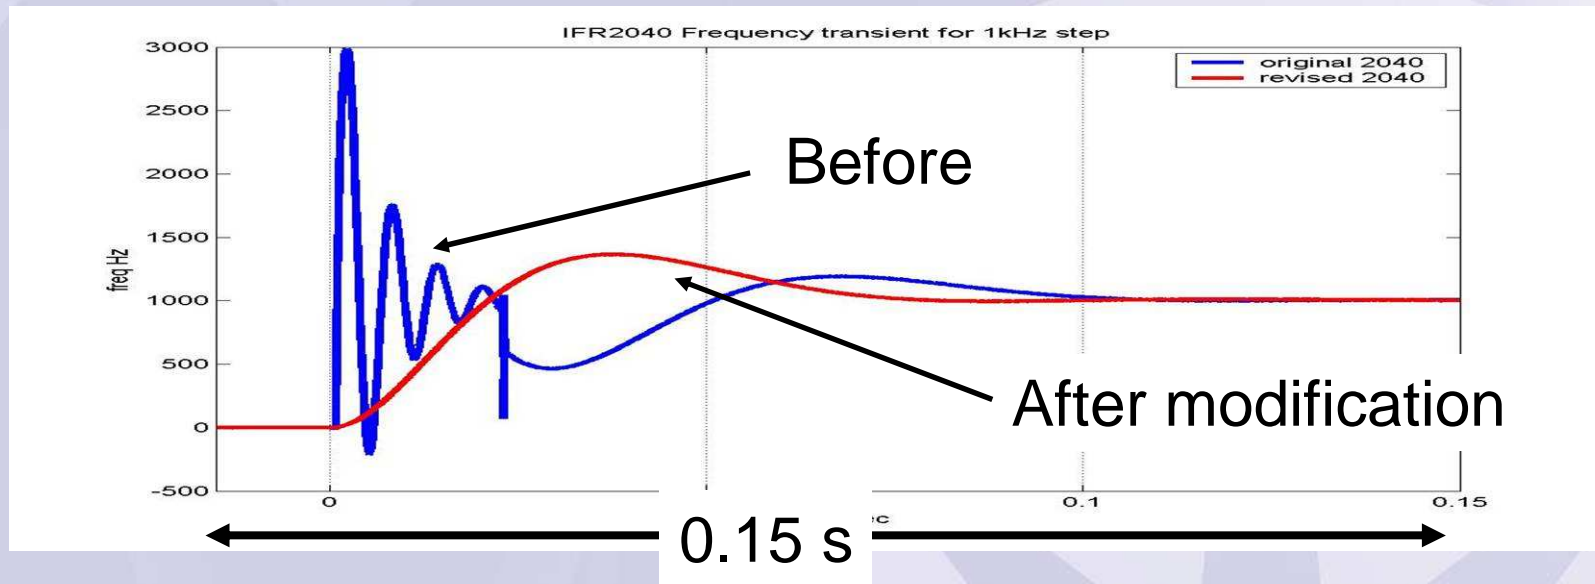
Frequency transient before and after MO firmware upgrade

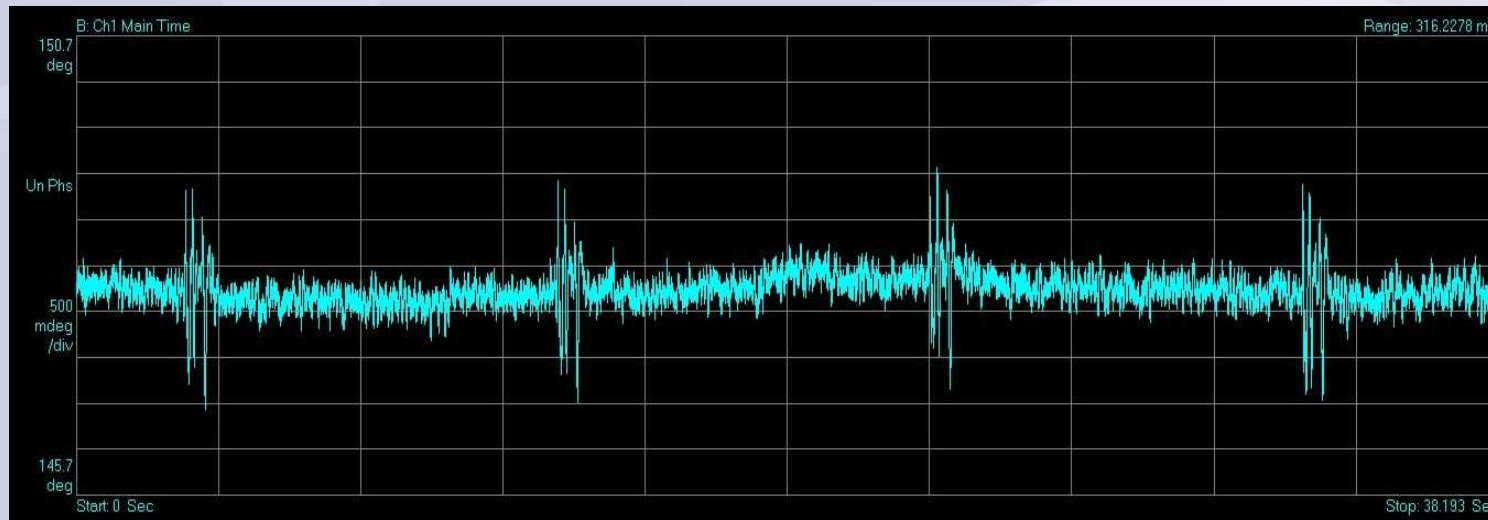
–Phase transient of $\pm 1.3^\circ$ when EPICS reads (queries) MO settings

Transient on cavity phase with EPICS MO read every 10 s

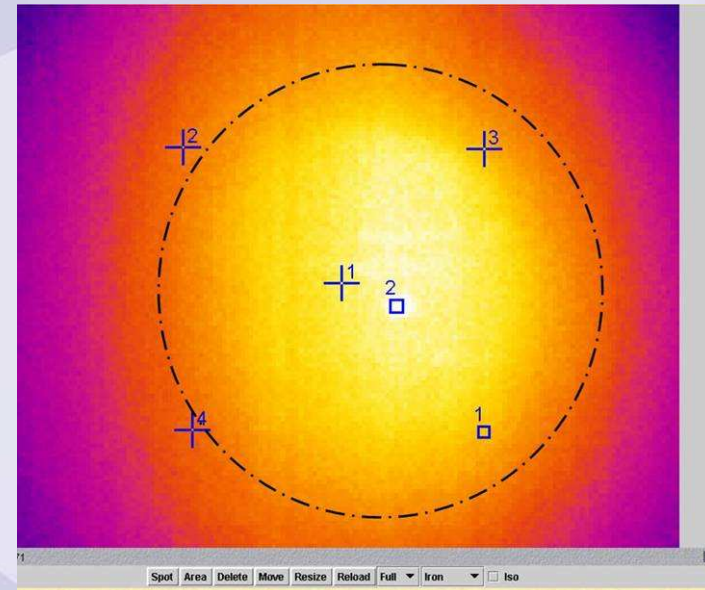
Thermal distribution with cavity detuned (73 kW, no beam)

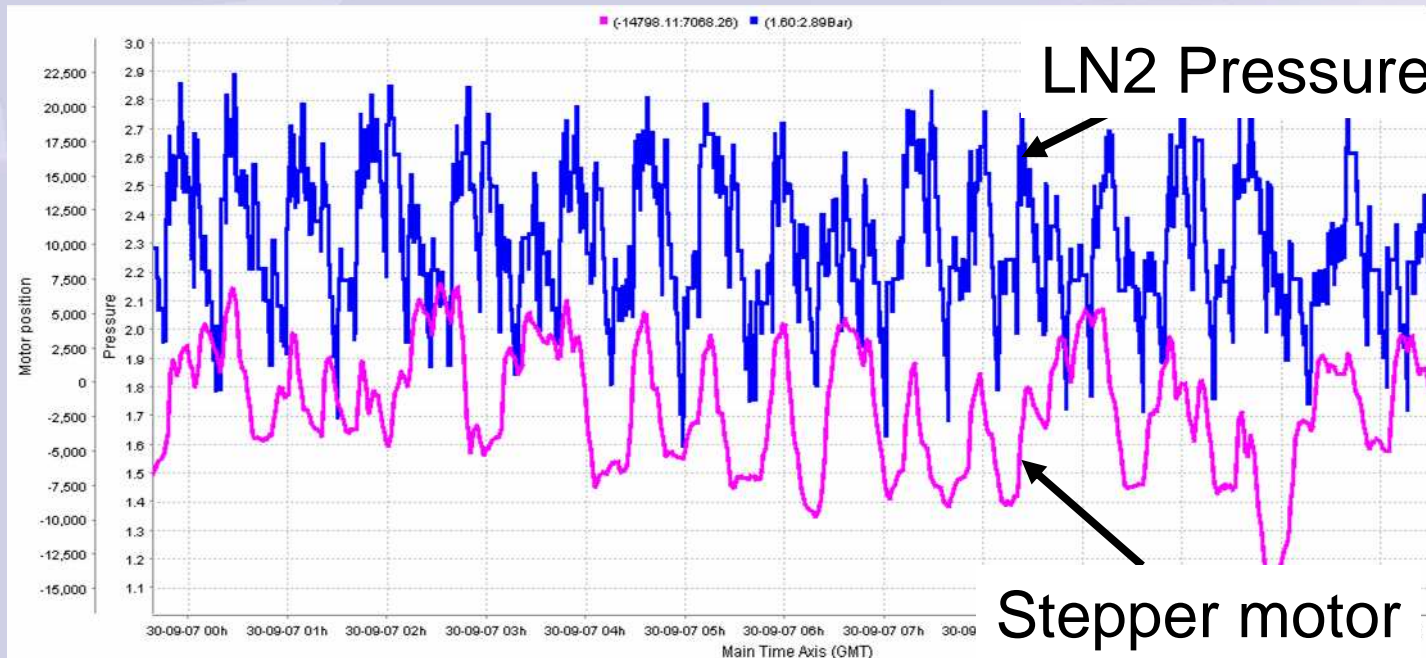
1 bar LN2 supply pressure variation leads to significant tuner motion

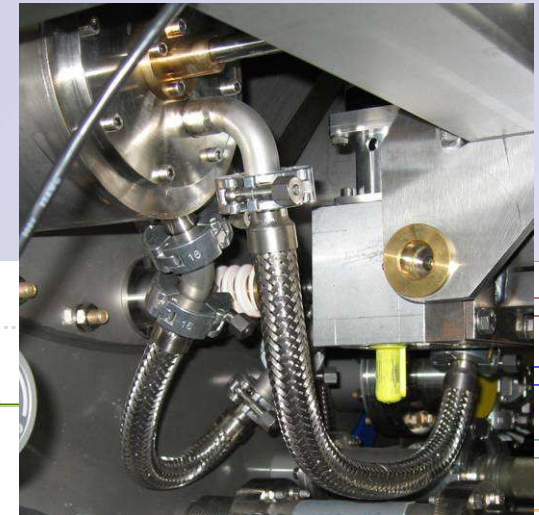
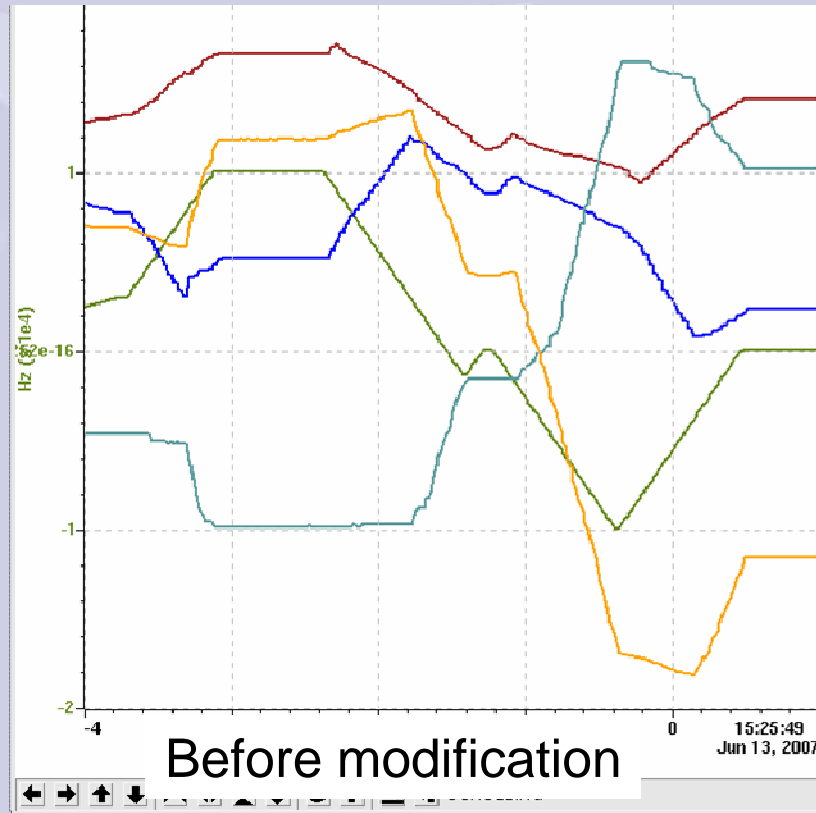
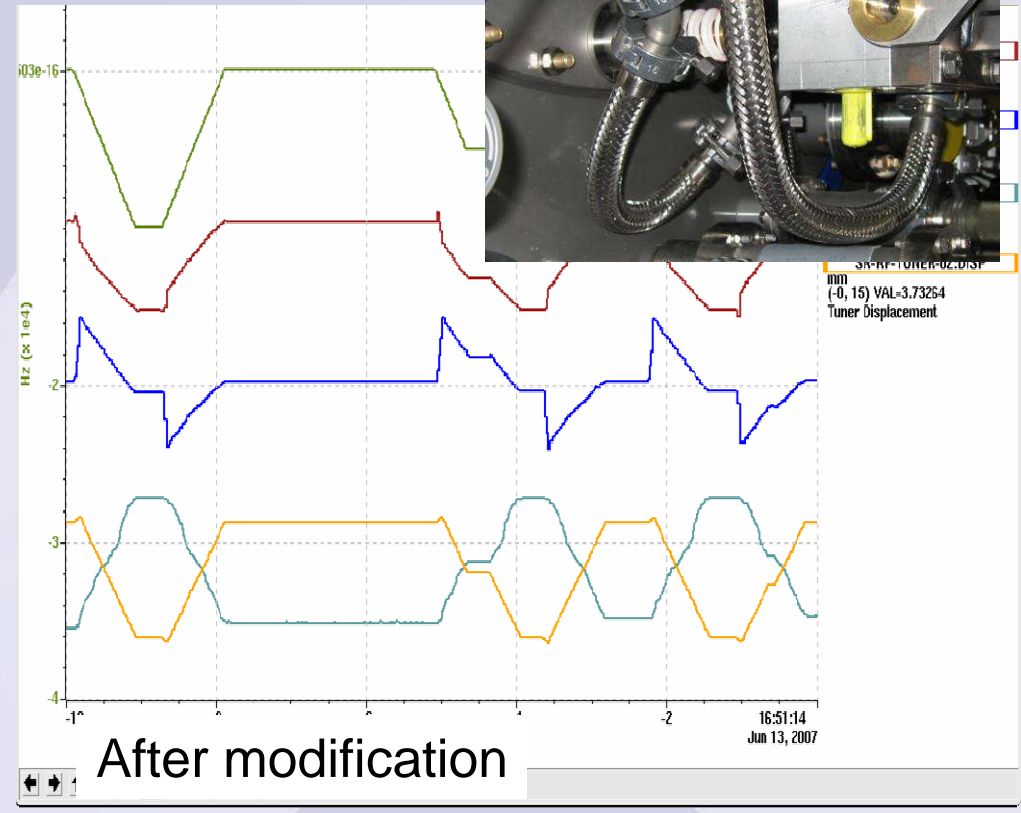
Significant phase jumps observed on cavity phase
Tuner found to be sticking, long backlash and jerky motion
Tuner was re-fastened and compensation bellows and
spring isolated

Cavity tuner operation has improved with mechanical changes:
generally $\pm 5^\circ$ tuner control rather than $\pm 15^\circ$ reported last
year

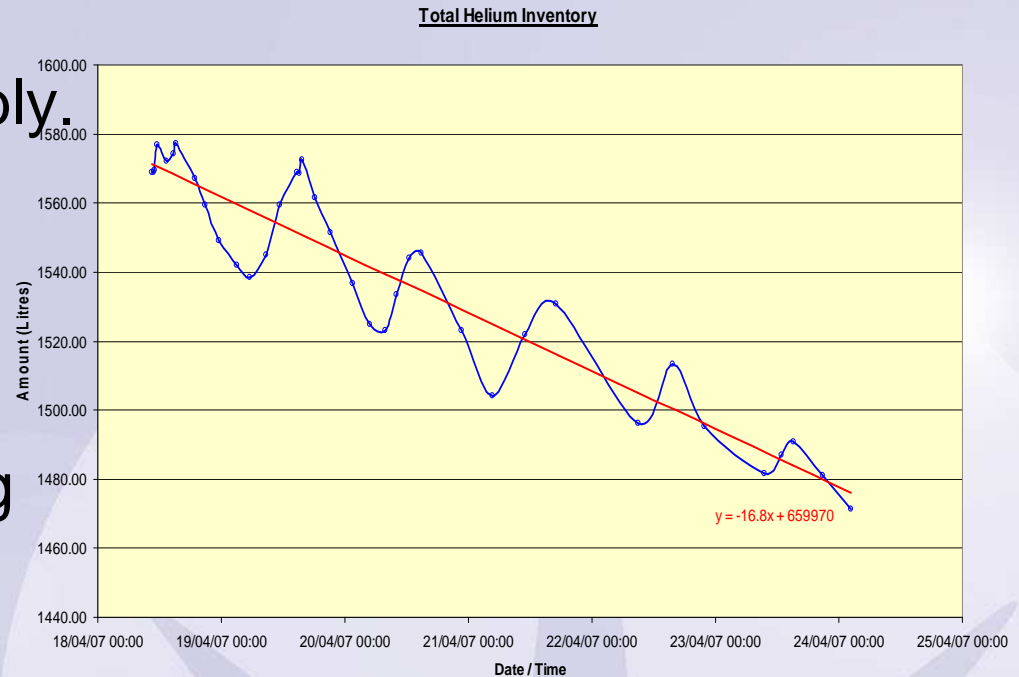
- Has operated very reliably.
- Problems this year:
 - Leak on pyrolyser
 - System leak following maintenance

Pressure in buffer tanks
Oscillation due to outside temperature
Downward trend due to leak
