Status and Operation of the ELETTRA RF System

Sincrotrone Trieste, Trieste, Italy.

Overview/Transmitters/Cavity Replacement/Conclusion

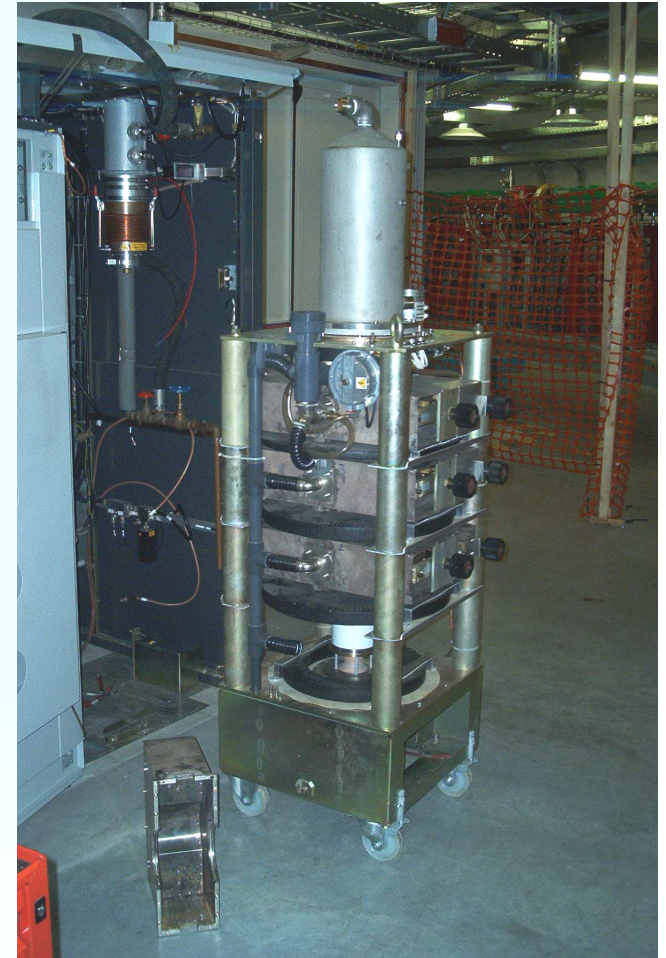
One Klystron's replacement

- April - Klystron replacement in RF transmitter # 3:

- after ELETTRA injection, the maximum output power was only 40 kW
- raised the collector current set but the gain was not restored
- fast drop of the collector current - from 5.2 to 4.6 A in half hour
- switched OFF the transmitter: down-time 2 hours, only 3 RF plants ON
- next day the klystron's replacement started: it lasted 4 days , including transportation, dummy load test etc.

The Klystron was Marconi k3672 BCD s/n 0994-0121 , lifetime 32557 hours, installed last September 2003

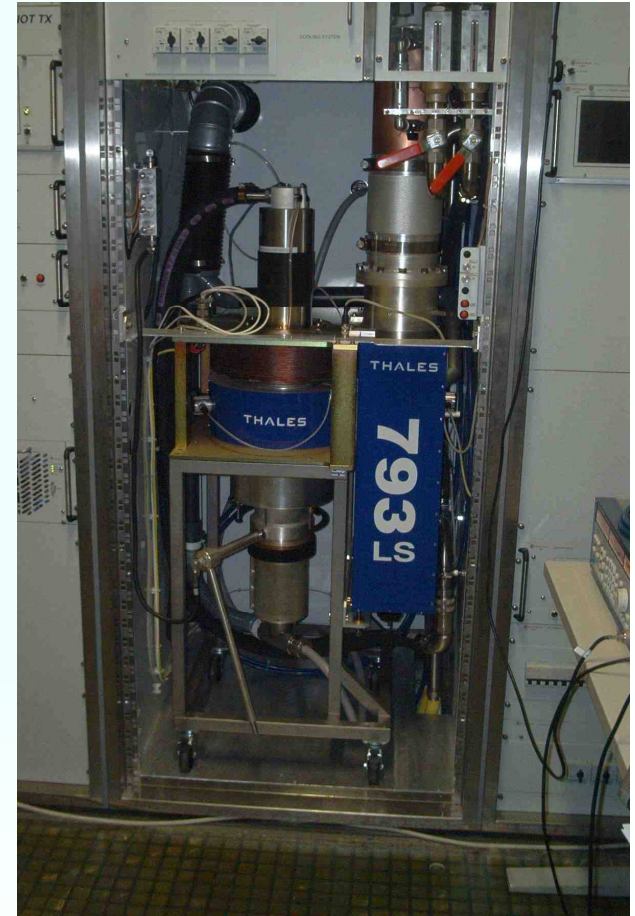
October 2008 I.O.T. TH 793-1 installation on Tx-A

- ✓ The TH 793-1 was shipped already installed in its trolley. Same input circuit of the TH 793 and new output cavities.
- ✓ Sincrotrone Trieste provided for:
 - additional cooling system for the output cavities
 - 6 1/8" output coaxial line
 - attenuated RF drive to limit the output power to 65 kW, during the ELETTRA run
- ✓ the tube installation and set up was done by Thales personnel
- ✓ 140 kW were certified on dummy load running the TH 793-1 s/n 617303 (Tx-A) and the TH 793 s/n 557132 (Tx-B) together
- ✓ no faults occurred during installation/check time

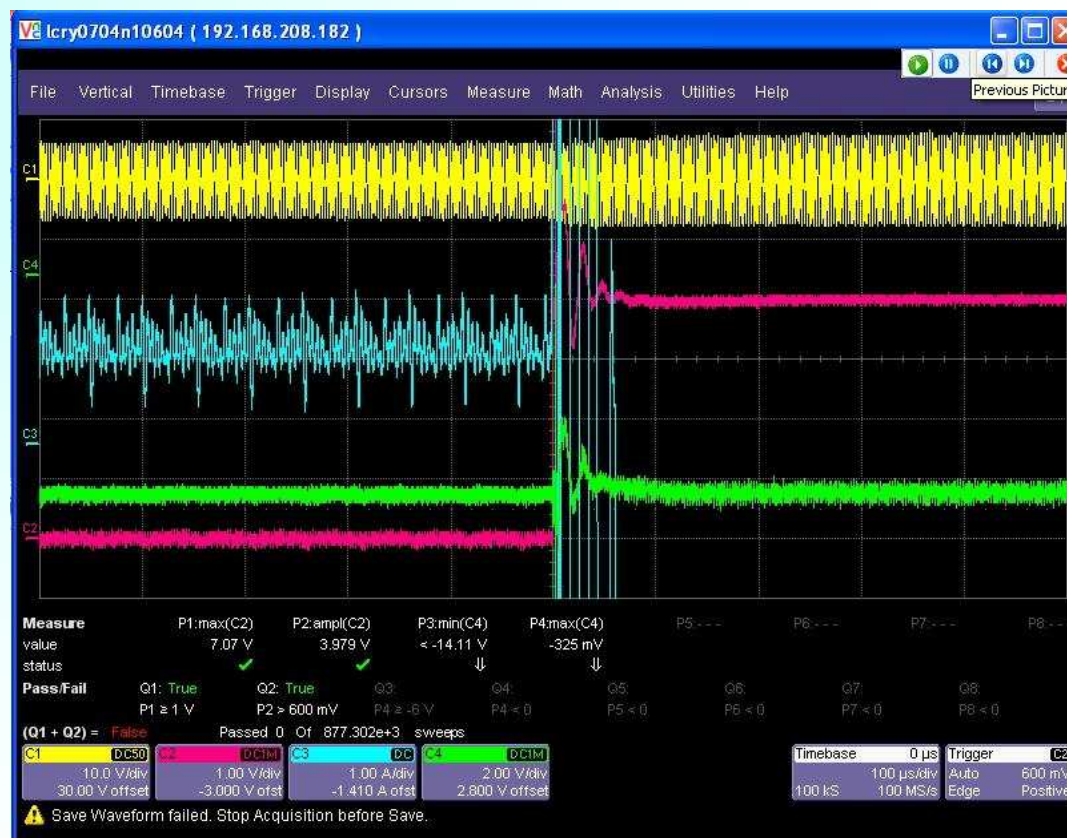
TH 793-1 “HV Inhibit” on the scope

Reflected power
from input circuit

Beam current

DC signal \sim HV voltage (1:5000)

Logical signal of the fault

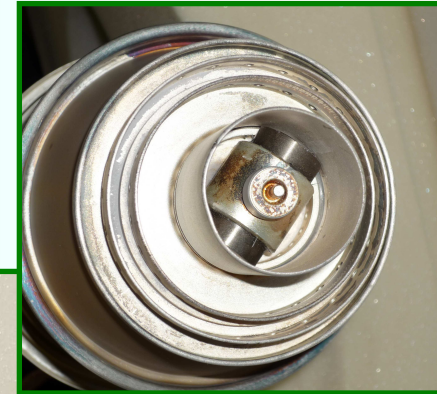
TH 793-1 and its input circuit

-**TH 793-1 False contact between the grid wire and ground pole of ion pump** in the input circuit. Breakdown not connected to the tube itself. Tube extensively checked.

white grid wire
bad insulated

It was already decided to replace the TH 793-1's input circuit with the TH 18793 LS s/n 47 (loan from Thales).

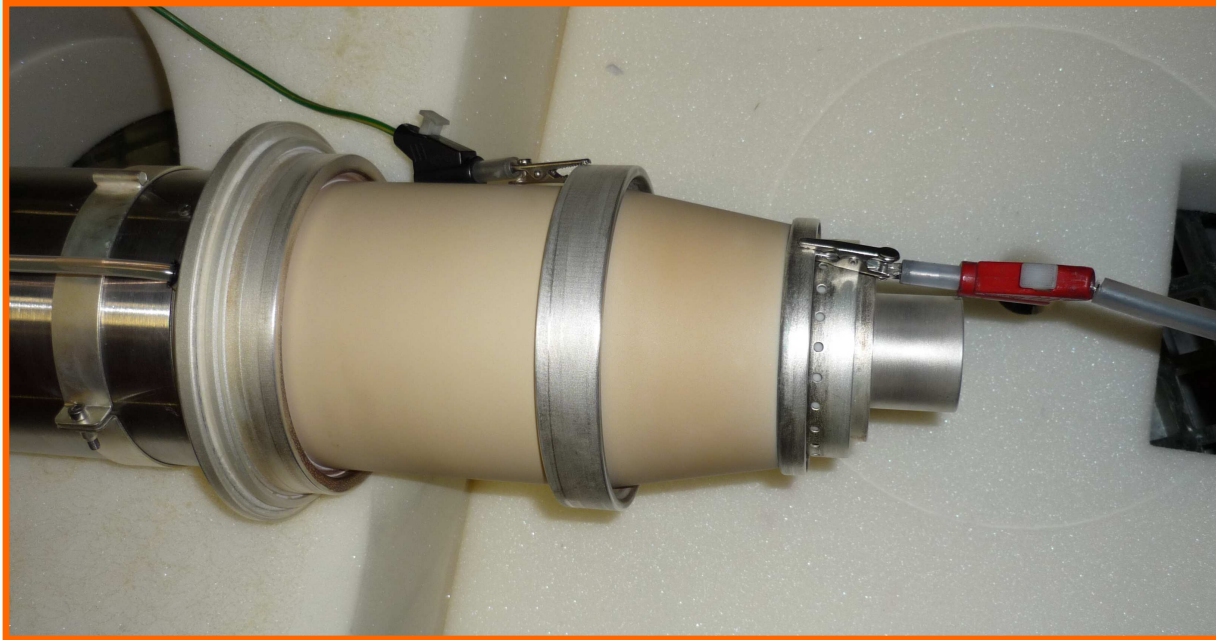
TH 793-1 check up

Vacuum test

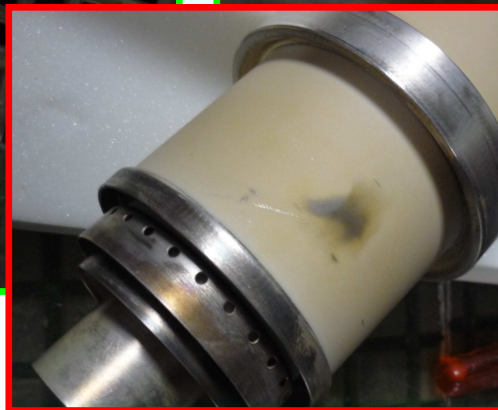
TH 793 and the input circuit

-**TH 793 Dark spot on the tube's ceramic and discharge imprint** in the input circuit's insulator. It should be cleaned and re-conditioned : tube shipped back to Thales factory.

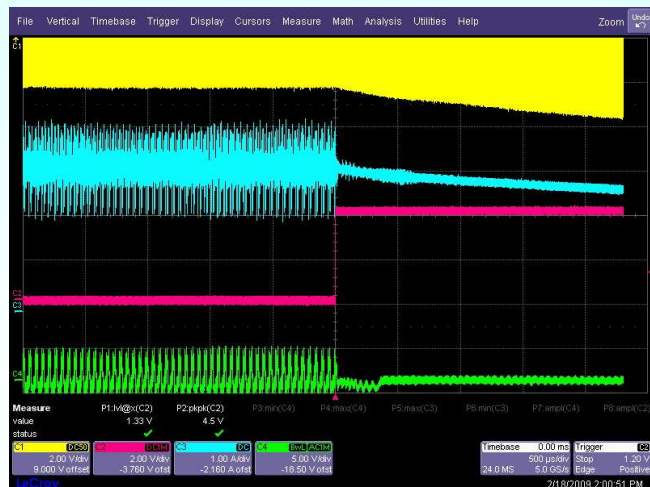
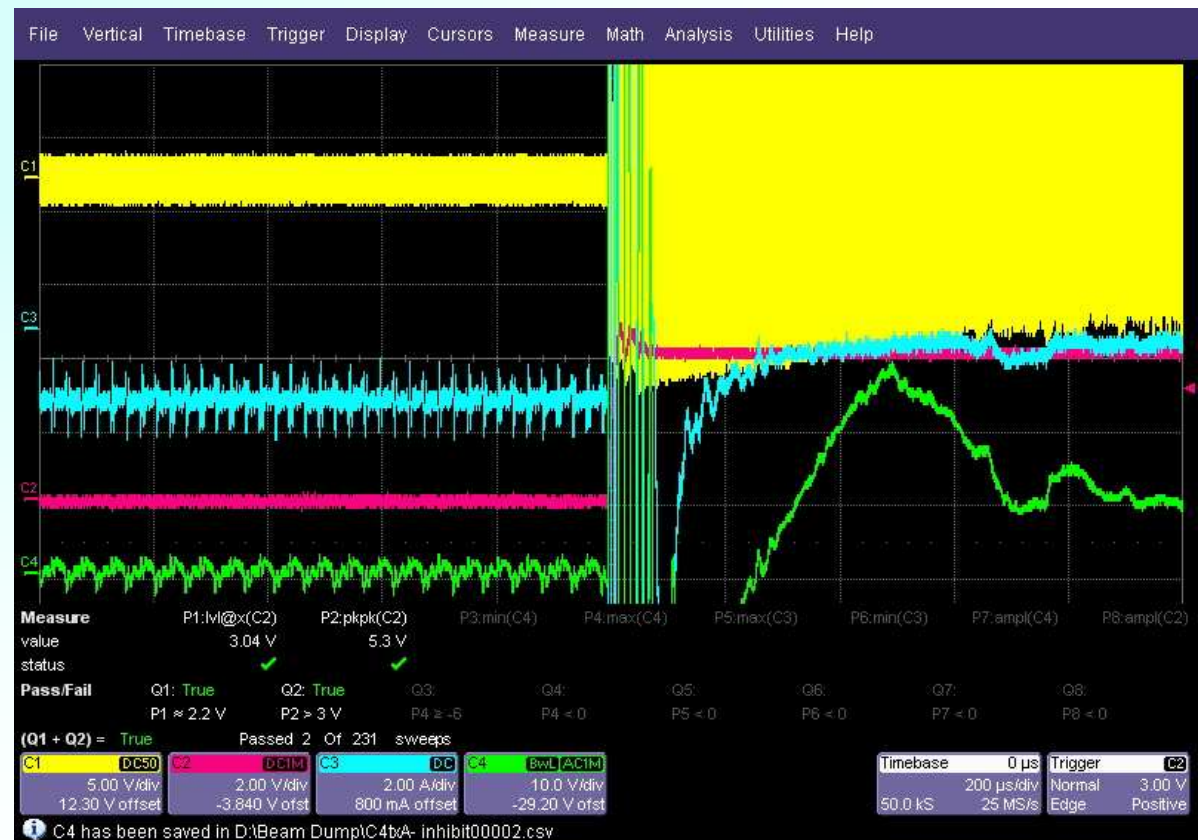
TH 793-1 final "HV Inhibit

C1: Reflected Power

C3: BeamCurrent

C2: Inhibit logical signal

C4: Body Current

HV Inhibit test

After only 93 hours the final “HV Inhibit” (28/02/2009)

the tube itself could not withstand more than 13 kV.

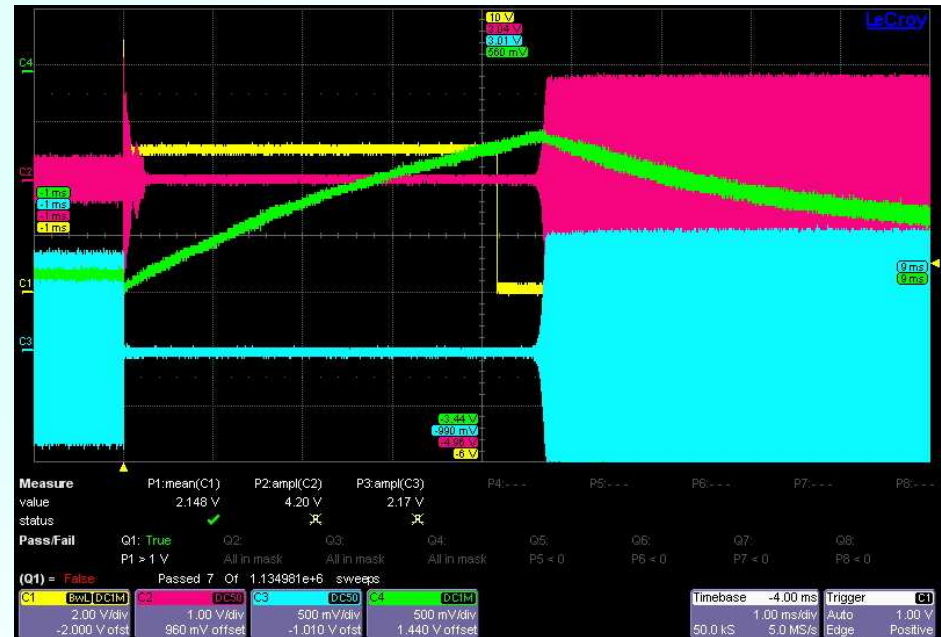
Cavity Amplitude Loop Modification for IOT Transmitter

The Elettra Beam Dump procedure is the interlock procedure to “kill” the accumulated electron current. It is done by switching OFF the RF for 4 msec.

The 500 MHz main RF generator STOPS for ~4 ms. NO driving signal for amplifier and no RF power in the cavities during this time interval.

At the beam dump, the amplitude control loop opens its control at the maximum output power the RF amplifier in accordance to the cavity voltage set by control -always 600 kV. When RF power back, the frequency loop starts to tune the cavity and the original power level is restored (~60 sec).

Reflected power Forward power

Beam Dump Signal Amplitude loop control

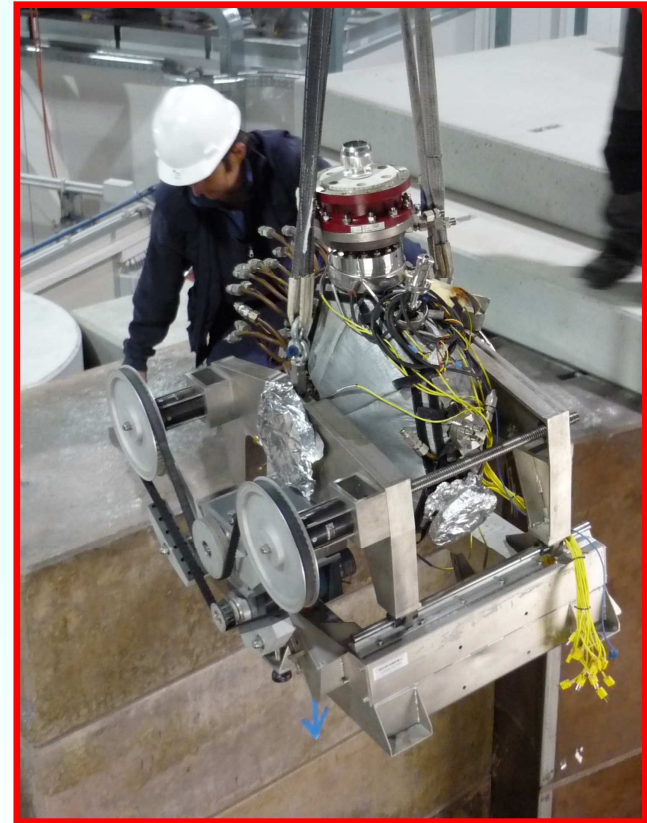
Old cavity removal

De-installation of the old cavity : RF high and low power cables, controls etc, waters, vacuum.

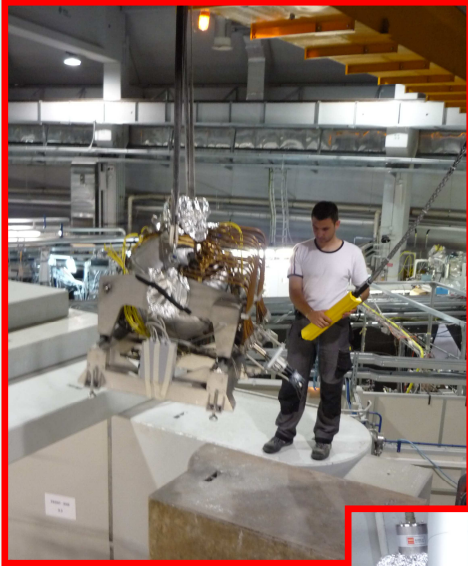
Installation of the cavity

Arrangement of new cavity : alignment, mechanical and water connections, vacuum leak test, bake out, RF connections, RF power conditioning (1 day- cavity already conditioned in lab), controls, calibration.
