# PETRA III Cavity HOM- story

PETRA III Cavity HOM- story

Berlin, 19<sup>th</sup> September 2013

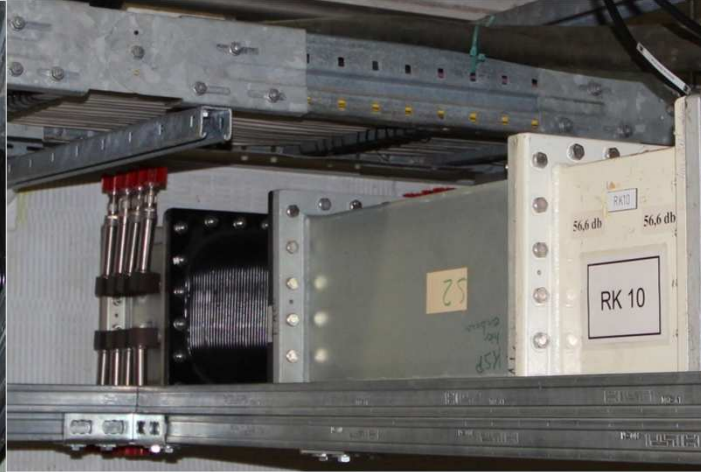
Some devices to suppress HOM's

16 HOM- antennas with absorbers in the feeding waveguide

Absorbed power = 80 W / system

(not coupling to fundamental mode)

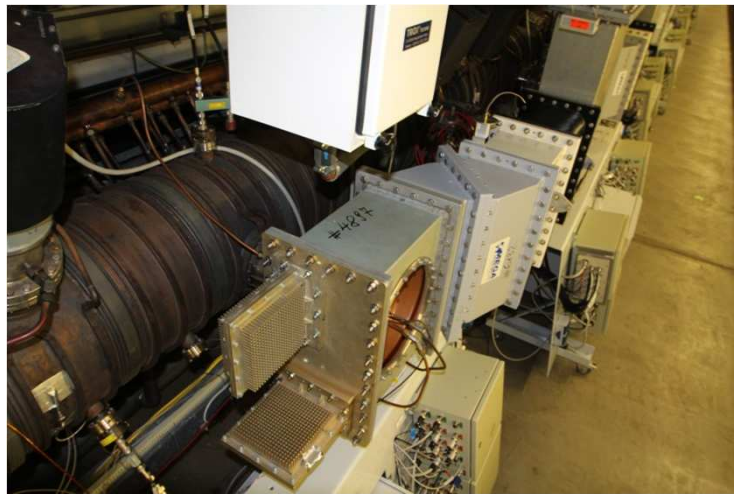
Each doorknob has HOM- absorber

(not coupling to fundamental mode)

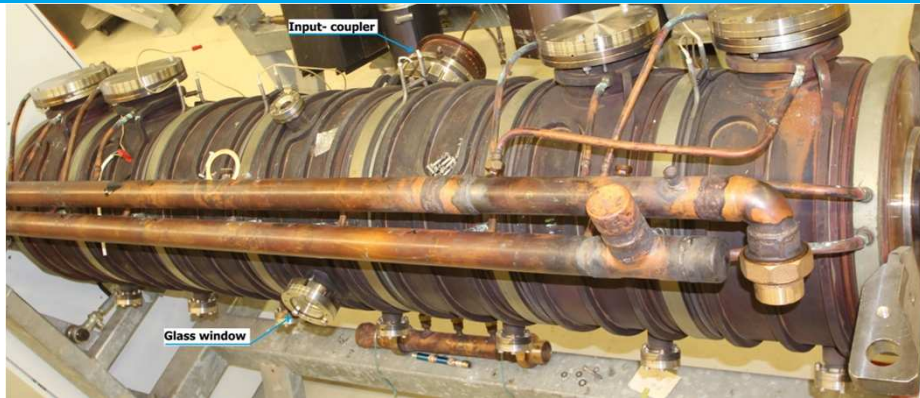
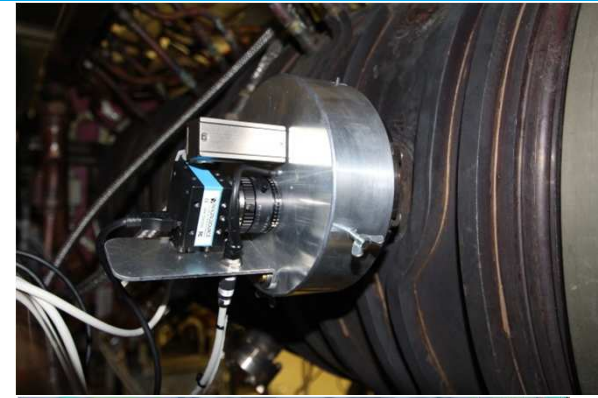
- Glass window for IPC- spark detector
- Coupler inspection through this window
- Camera to have always same conditions

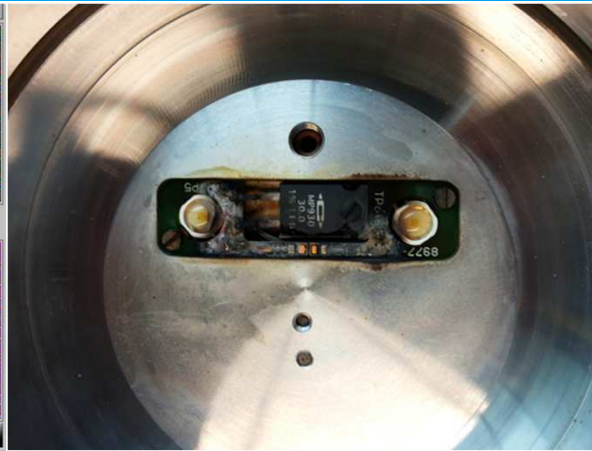
Melted electronic in camera cup

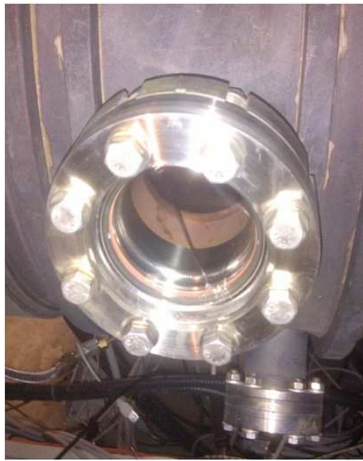
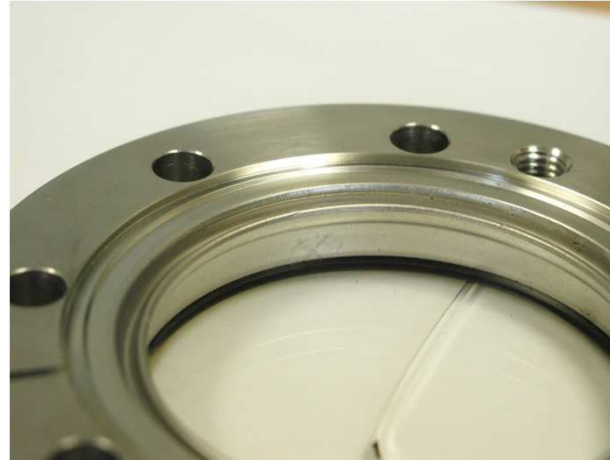
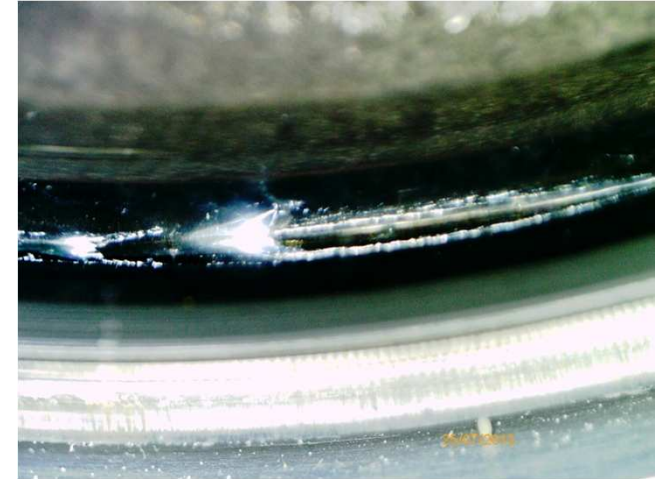
Due to heating the window by HOM's:

- One window broke (didn't we had such an event some years ago? Oh yes, in 40 bunch mode ;-)
- Lots of them had crackles in the glass
- Parts were replaced and IR- thermometer was installed

After recovery : Test- run 80 mA in 40 bunches for investigations

- 210°C at the window ( estimate 300°C with 100 mA in 40 bunches )
- Temperature gradient, at beam dump starts with 30° / min (200°C => 170°C in 1 minute)
- Higher Bunch numbers are less critical

Consequences:

- Limitations in current at certain bunch patterns
- Develop device to protect the window

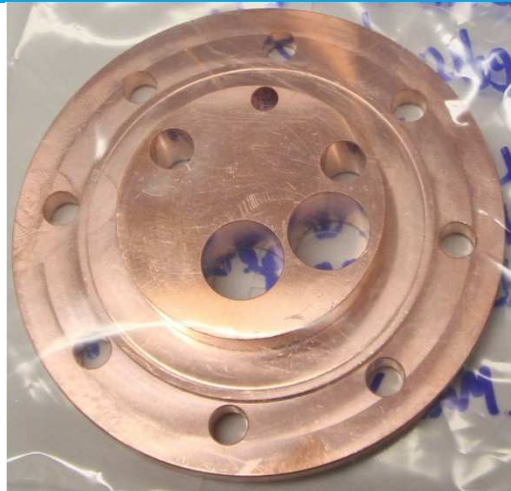
RF- filter and vacuum seal  
With holes for

- Camera
- Light
- Spark detector

2 week ago, installed at all PIII- cavities

Test run with 100 mA/40 Bunches no glass heating anymore
