250-kW Upgrade of Cavity Couplers for PETRA-3

- Coupler Design and 35 years passed down Experience
- Traditional Pre-treatment and Conditioning Method
- Successful Improvements
- The Really Breakthrough
- Present State-of-the-Art
- Summary

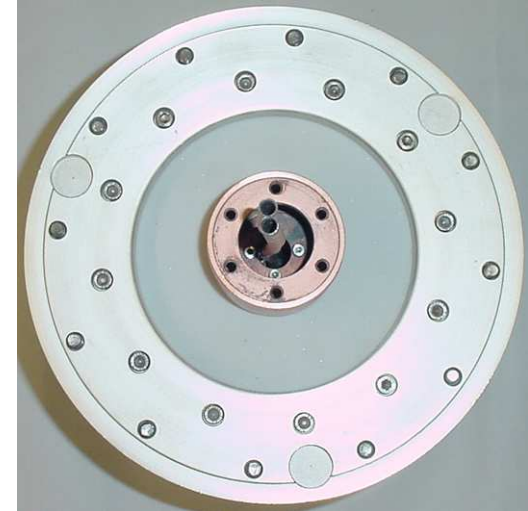
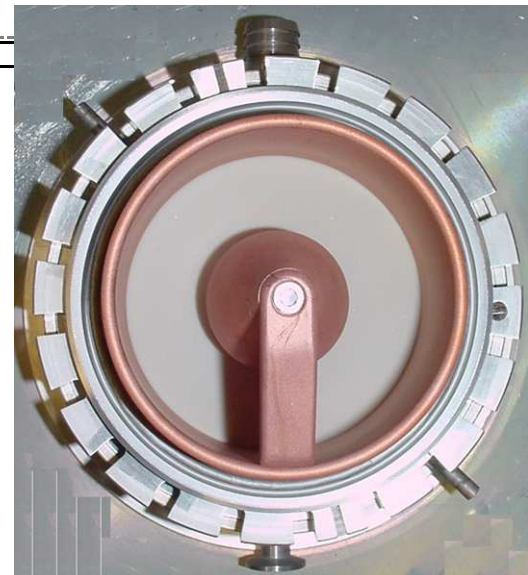
- Originally designed for DORIS-1 in 1972
- Nominal power 60kW, max. tested up to 140kW (once?)
- Modified for PETRA-1 1976 (mech. length reduced)
- At last 114 couplers were in Operation at HERA, PETRA-2, DORIS-3 and DESY-2; all operated at <90kW
- Most couplers could be operated save up to 100...120kW after a careful condition process.
- But some couplers failed already during the conditioning process at 50...70 kW.
- On the other hand very few couplers could be conditioned up to > 500 kW.

The vacuum window assembly remained unchanged since 1972

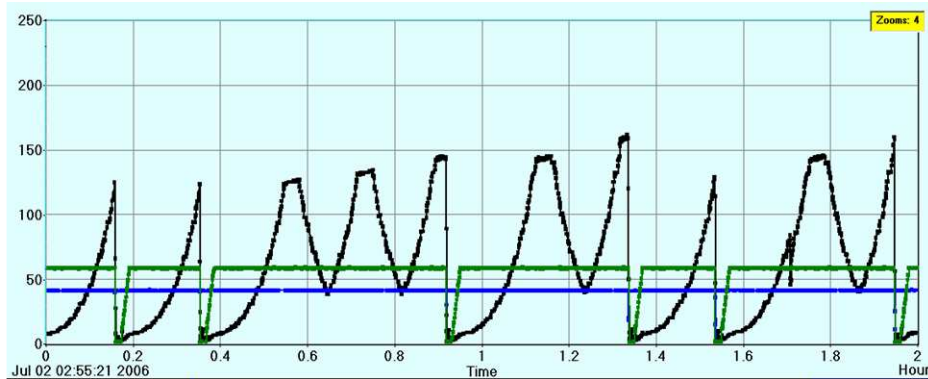
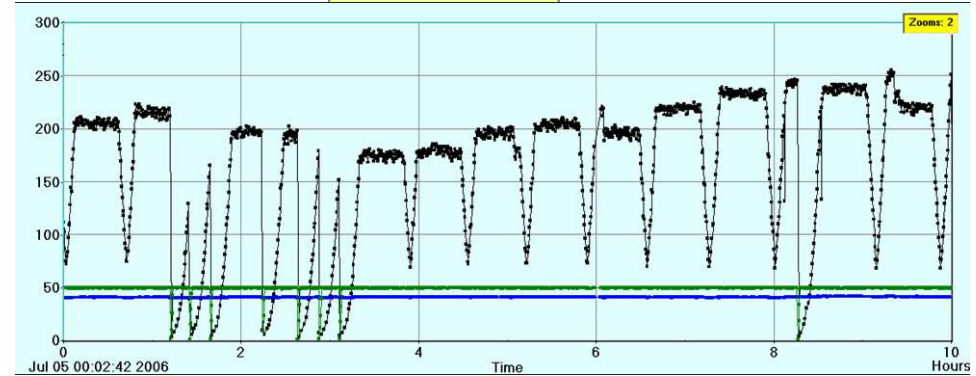
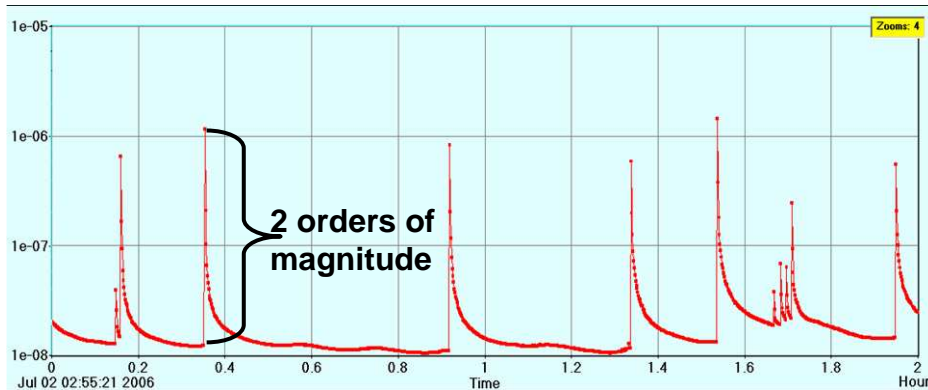
After 40h conditioning the progress stagnates due to strong sporadic outgasing

By extending the time of the Intermediate Plateau from about 2 to 30 Minutes the strong sporadic outgasing has been overcome

RF-Power [kW],

Klystron-HV [kV],

Klystron Drive Power [W],

Cavity-Vacuum [mbar]

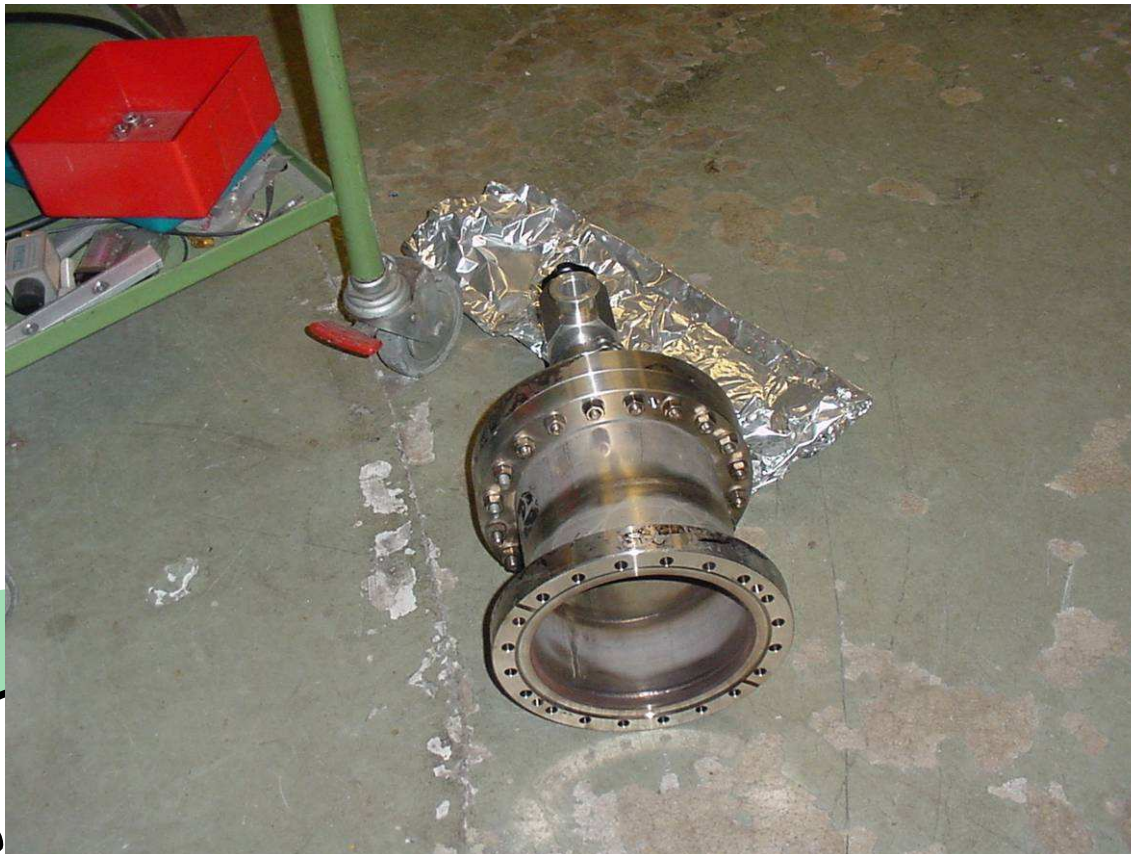
One day in July '06 I saw the exhausting vacuum chamber lying on the dirty floor.

- The vacuum surfaces of 4 couplers were sandblasted.
- Result: all reach >250 kW without any problem.
- New question:
 - Were problems really caused by deep contaminations?
 - Or was multipactoring the problem?
- Experiment:
 - Of one coupler only the centre conductor was sandblasted.
 - Of another coupler just the outer conductor was sandblasted.
- Expectation:
 - **Centre conductor sandblasted** should help if m.p is the cause of arcing. Because the brazed joint of the centre conductor was suspected to be a source of m.p..
 - **Outer conductor sandblasted** should help if contamination is the cause of arcing, because the surface of the outer conductor is > 2.3 times the surface of the inner conductor.
- Result:
 - **The coupler with centre conductor sandblasted reach >250 kW without any problem.**
 - **The coupler with outer conductor sandblasted failed.**

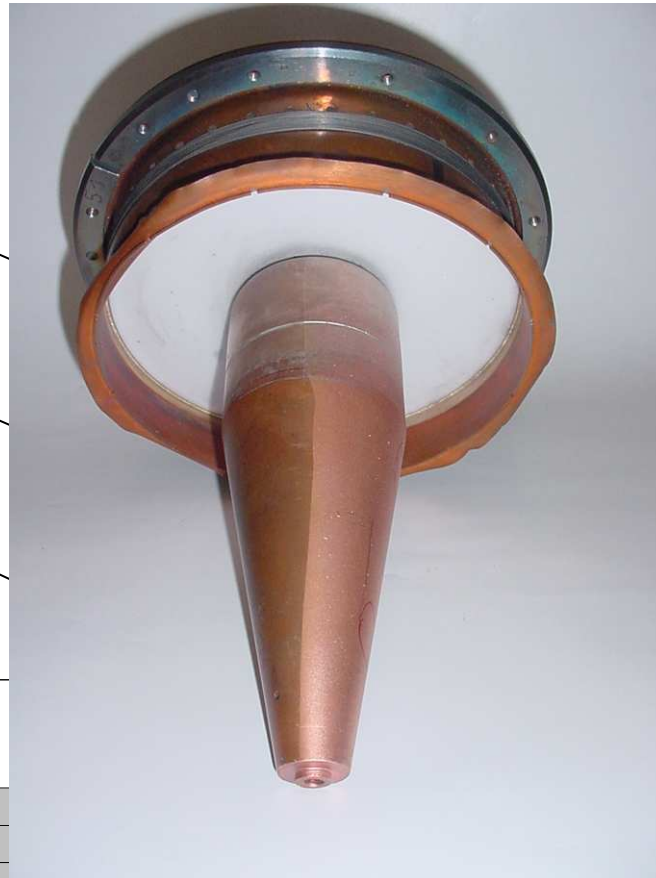
Before Sandblasting

$R_a = 0.624 \mu\text{m}$
 $R_z = 3.82 \mu\text{m}$

$R_a = 0.380 \mu\text{m}$
 $R_z = 3.00 \mu\text{m}$

$R_a = 0.338 \mu\text{m}$
 $R_z = 2.05 \mu\text{m}$

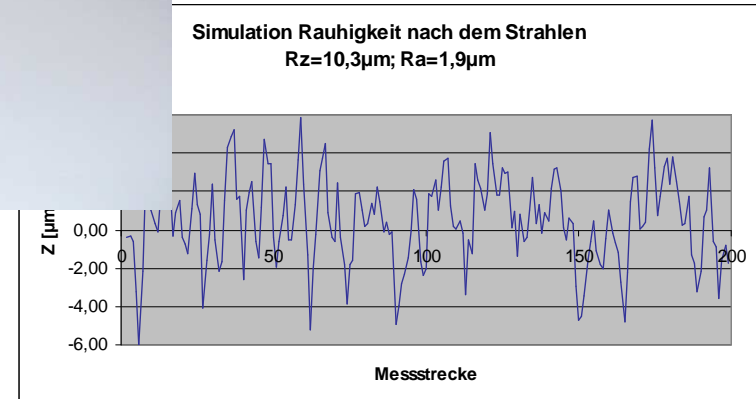
After Sandblasting

$R_a = 1.651 \mu\text{m}$
 $R_z = 9.46 \mu\text{m}$

$R_a = 2.164 \mu\text{m}$
 $R_z = 11.9 \mu\text{m}$

$R_a = 1.994 \mu\text{m}$
 $R_z = 11.6 \mu\text{m}$

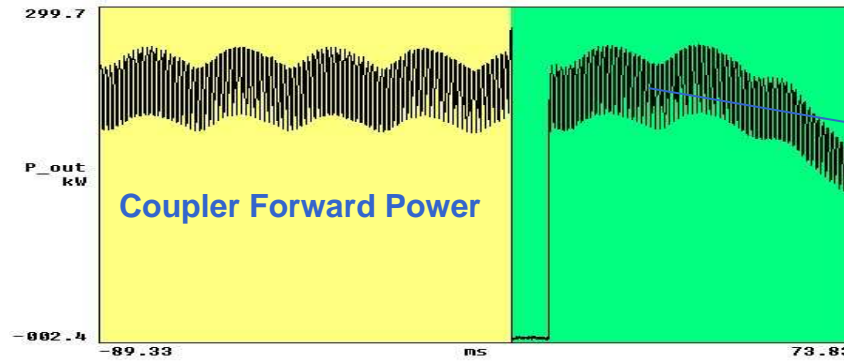
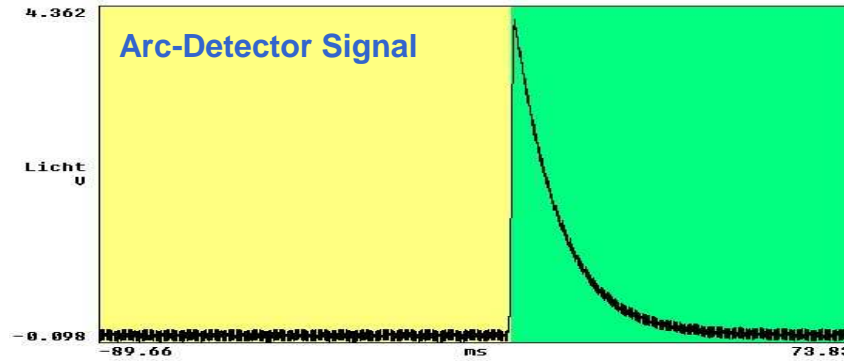
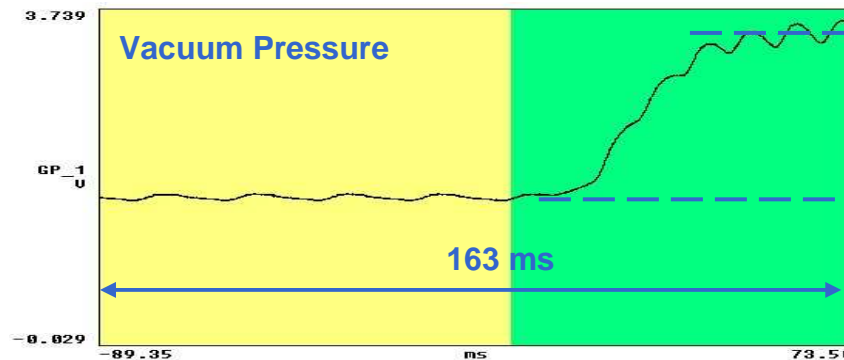
Arc-Detector vs Vacuum-Interlock

FM
Frequency Deviation: 100 kHz
Modulation Frequency: 400 Hz
