# SLS RF operation report 2003

# <u>M. Pedrozzi</u>, Jean-Yves Raguin Paul Scherrer Institute, 5232 Villigen PSI, Switzerland

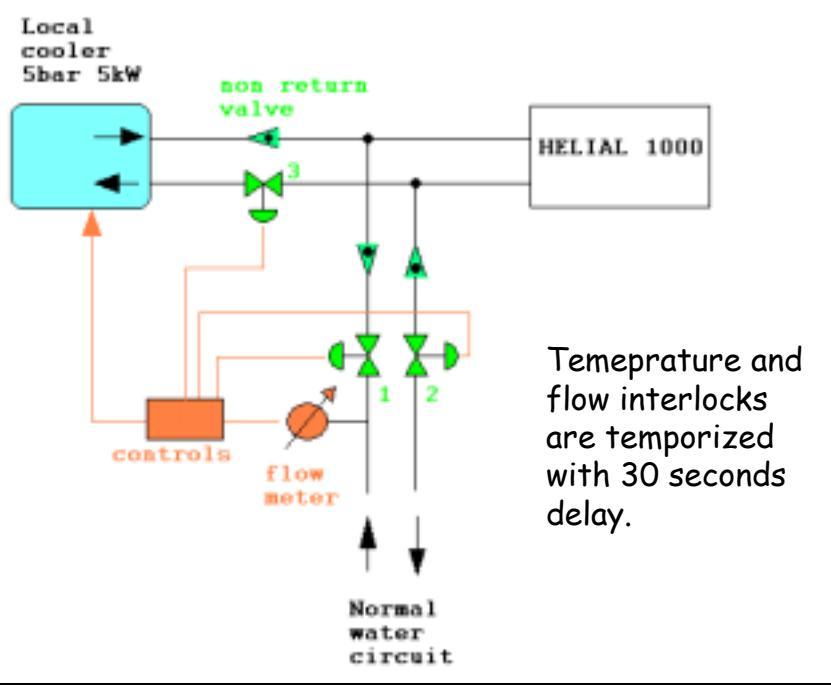
#### What we learned during operation?

- 1) Because of the stable top-up operation the cavity can be operated at fixed tune (good for tuning motors).
- 2) Due to external temperature changes (winter-summer) the main SR frequency can considerably change, the voltage should be consequently verified manually from time to time (this Year 5.5 kHz excursion at 500 MHz, 16.5 kHz at the third harmonic because of temperature stabilization problems during the hot season).

- 3) In the SLS the same tune (~ +65kHz) can be used to stable fill the machine up to 300 or 400 mA.
- 4) Stable operation at 400 mA has been well established (life time improvement ~2.2). No additional radiation losses with respect to 300 mA operation.

- 5) The cooling system for the refrigerator turbines should have a redundancy to overcome failures or to allow maintenance of the main cooling system.
  A complementary cooling rack will be mounted during the October shut down.

- 6) We should avoid all source of vibration on the cold box (primary pump of the isolation vacuum)
- Spare turbines ready to be mounted are Probably a good investment.
