Past Years "HighLights"
of DESY RF- Group

Past Years "HighLights"
of DESY RF - Group

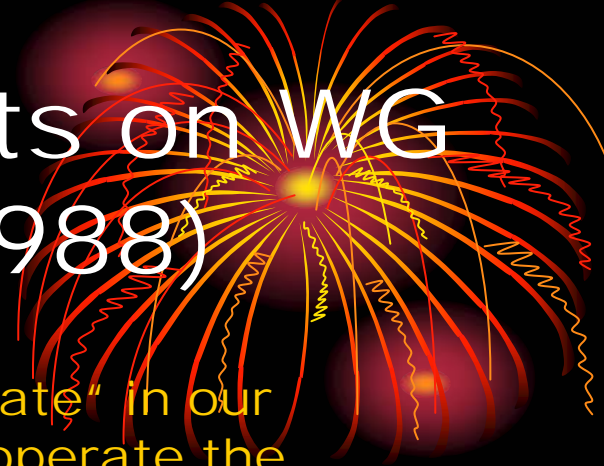
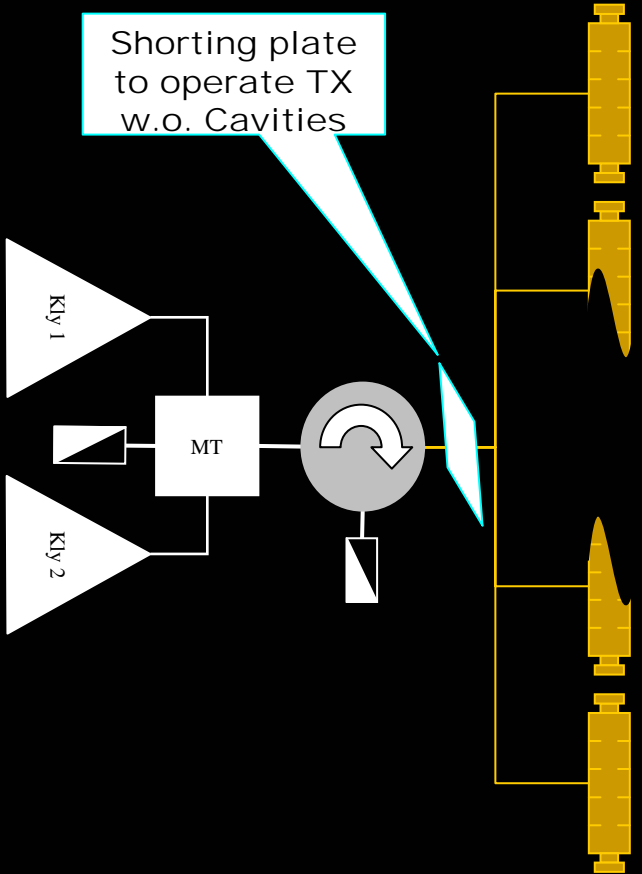
Bad interlock contacts on WG shorting plate (1988)

We have a „shorting plate“ in our waveguide system to operate the Transmitter without the cavities.

In „short operation“ the cavity interlock is deactivated (done by a micro switch)

After a “shut down” this micro switch had permanent contact.

☞ Cavity conditioning without cavity interlock!!

What did we learn:
Use switches, that do not stick together.

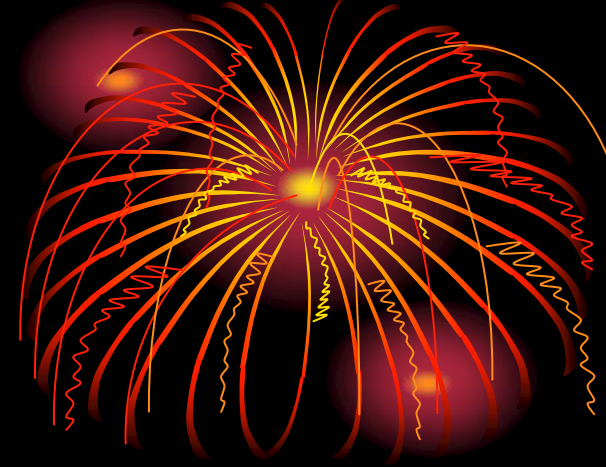
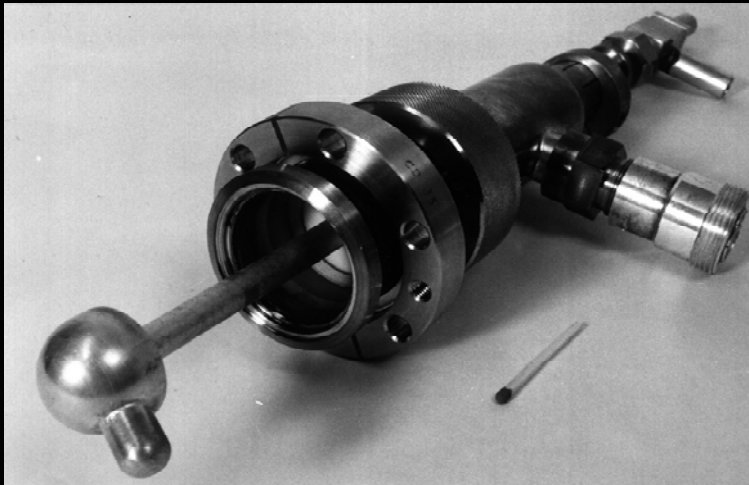
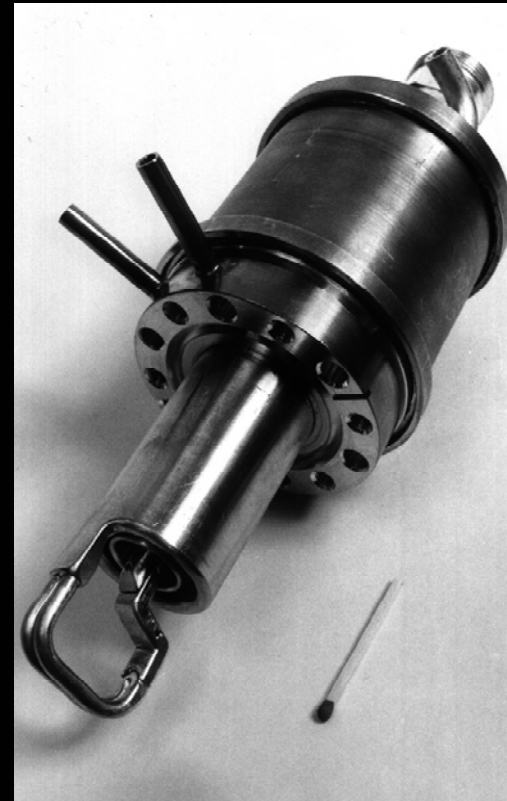
HOM- antennas in DORIS

We had HOM- antennas in our 5- cell cavities at DORIS.

One inductive and one capacitive antenna per cavity

Each one is water-cooled.

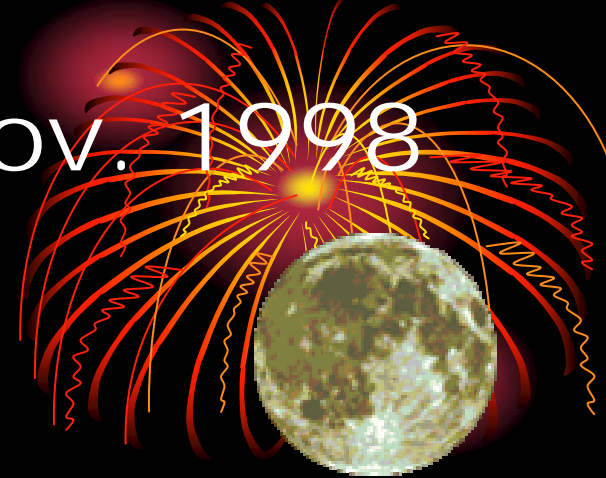
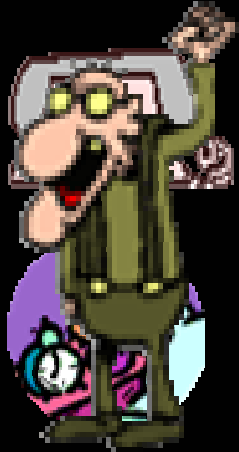
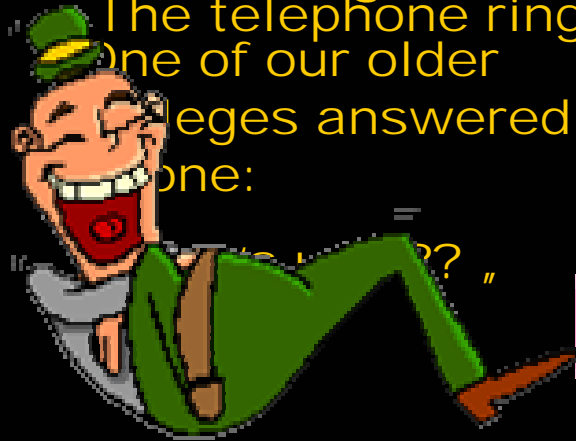
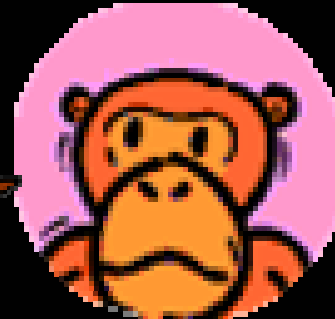
Flooding a Klystron Nov. 1998

Late at night !!
The telephone rings !!
One of our older
teleges answered the
phone:

You're kidding, there is only water in the
lower part of the klystron.
There is water flowing out of
The gun area isn't water-cooled!!!
the High Voltage Housing..."

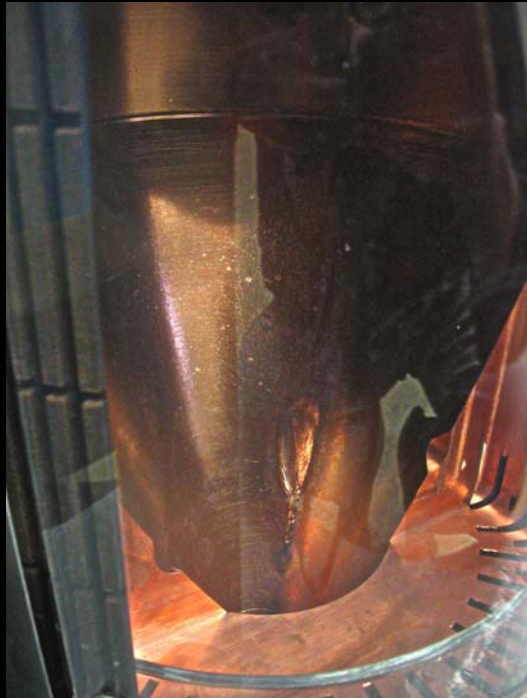
But:

- If the focus trips
- the interlock fails
- Some racks have no power

then the beam
melts a hole in
the collector
and...

Design the interlock (contacts) power
fail save

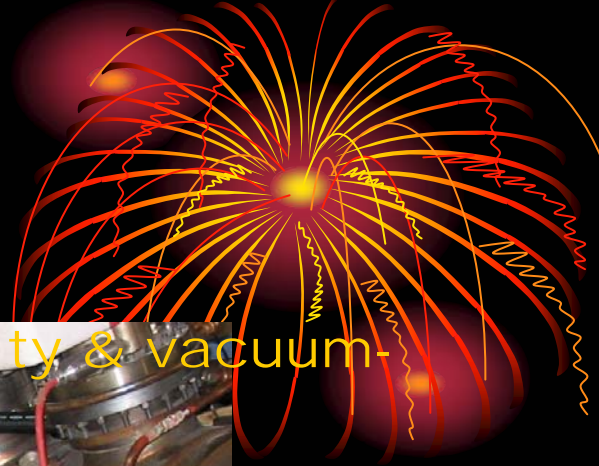
Flooded Cavities (2000)

- Transport vehicle hit water pipe of cavity & vacuum-bellow
- Big hole in pipe - very small hole in bellow
- Water shots in very small hole of the bellow
- 2 Cavities were flooded with some 10 liters of water
- Surface of other 10 cavities covered with water drops

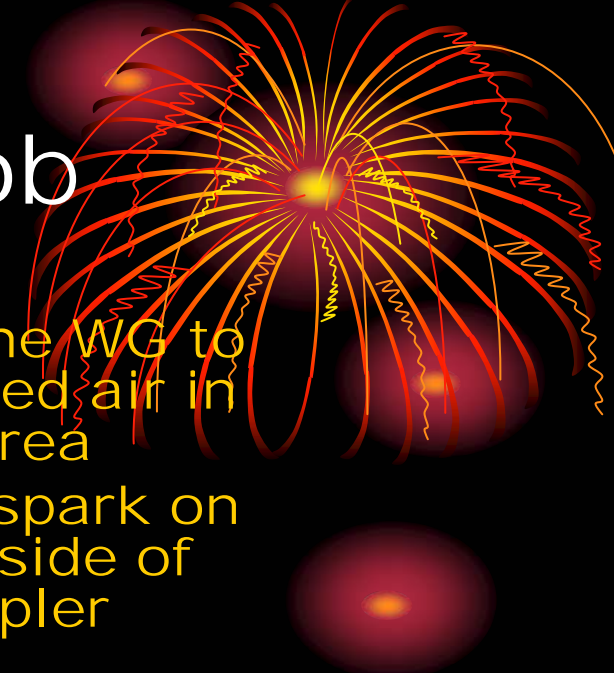
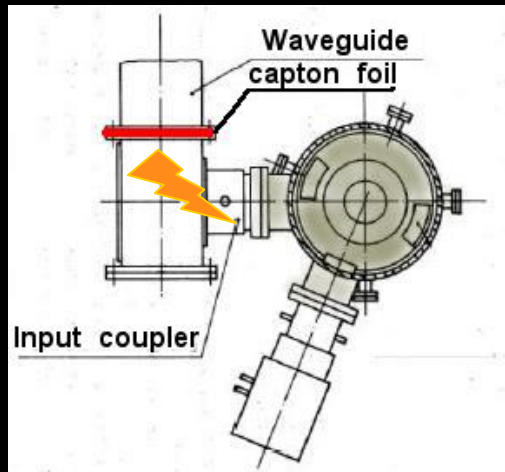
Sparking at a doorknob

- We shutted the WG to keep the forced air in the coupler area
- There was a spark on the air- flow- side of the input coupler

The spark produced a pressure- wave, that deformed the doorknob

What did we learn from that:
No capton foils to close to
"sparking risk" areas

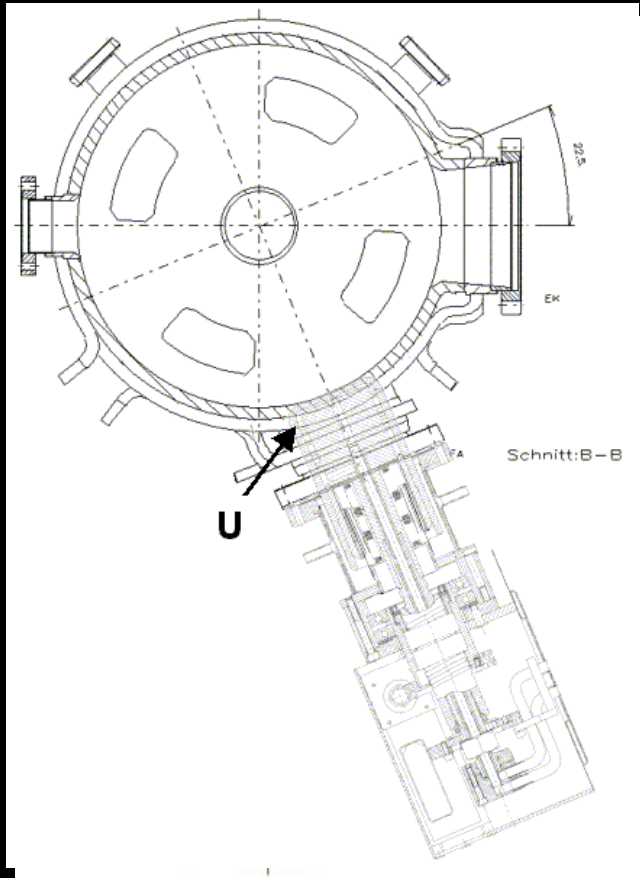
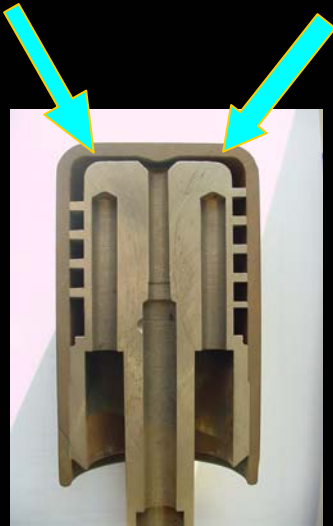
Plunger deforming (2002)

Usually our plungers are mounted on the top of a cavity

But there is one area, where they have to be on the bottom side

.. and for some reason we had to decrease the water flow (*seems to be no problem – deposited power is small*)

Air -bubbles move
to the top of a device
What did we learn from that:
So there is no cooling at
Keep the water flow big
enough, that there are no
bubbles in the system
all
The plunger get's hot and
looks like

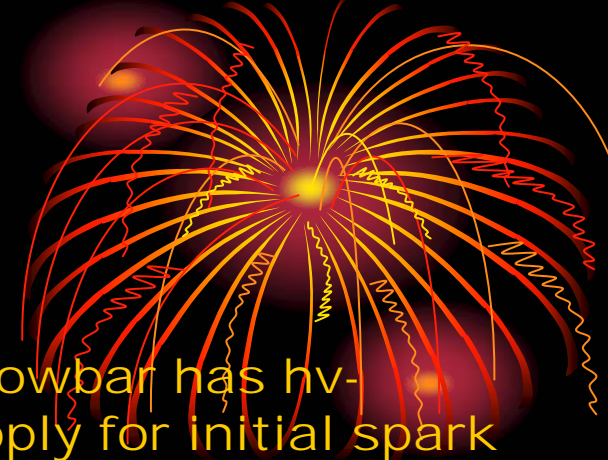
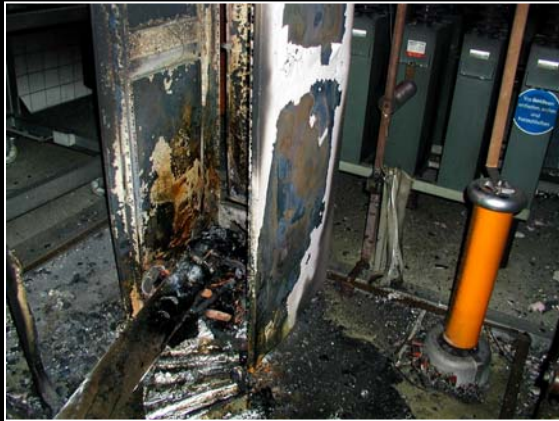
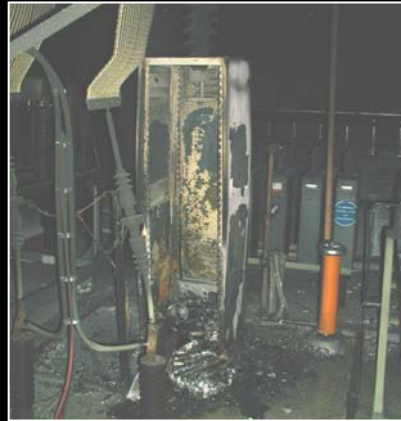
Crowbar burns (2003)

- Crowbar has hv-supply for initial spark
- Discharge-resistor went hot and damaged hv capacitor
- Leakage current
- Heat, fire

- What did we learn from that:
 - Design your components to be operated 24 hours / 7days
 - Spent time on inspections of your components at regular intervals
