Diamond Storage Ring RF Update

ESLS-RF 2006

Morten Jensen

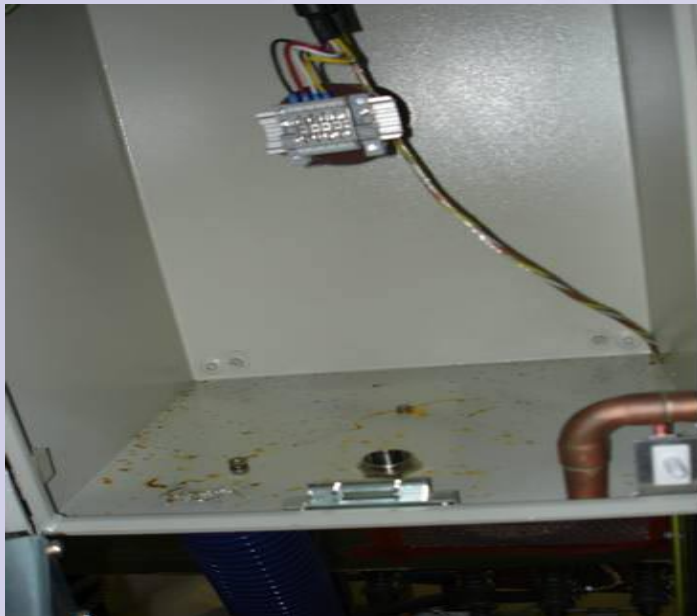
Flood in RF hall

Gasket failure in service gallery

Water came through plaster board on top of IOTs, combiner, helium fridge, racks and T&M equipment

Corrosion and dust deposits
within 24 hrs

Significant refurbishment by Thales, all IOT cavities demounted, cleaned and repaired

Significant refurbishment by Air Liquide, but mainly electronics damaged

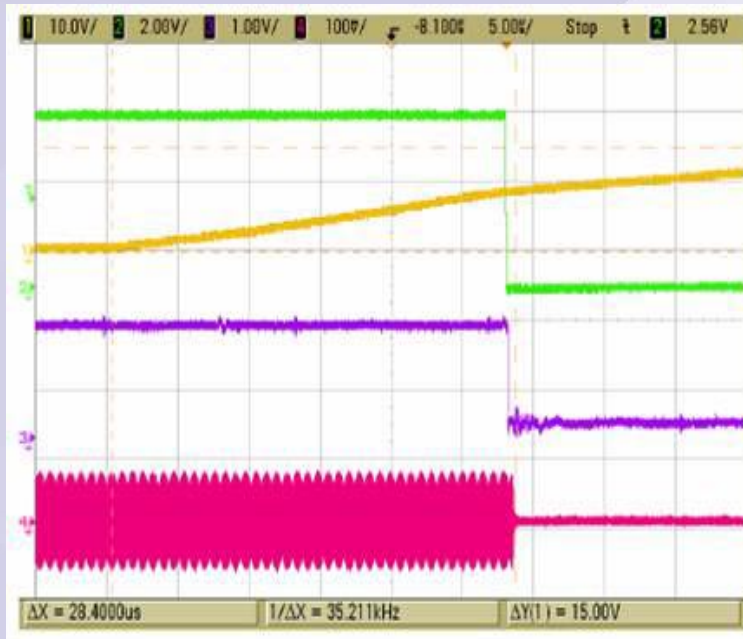
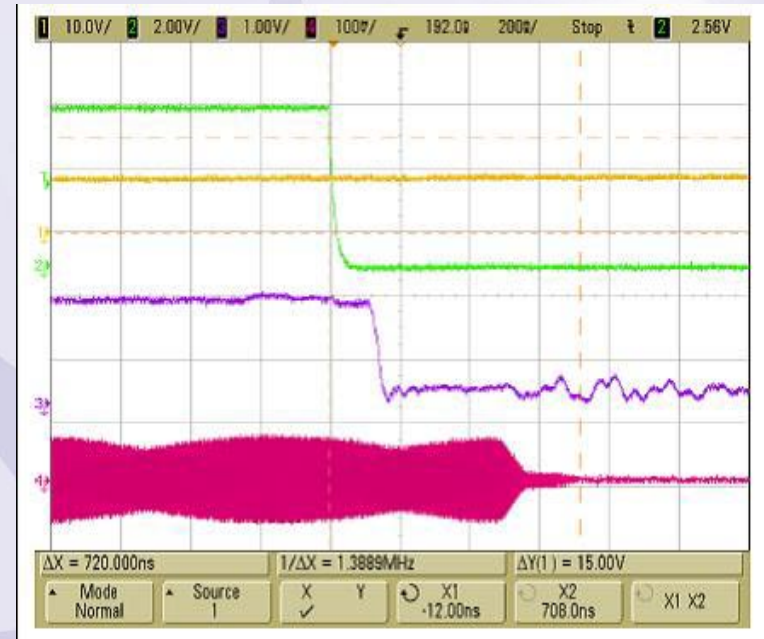
Selection of Results from 250 kW acceptance tests

Shut down time following trip (eg cavity arc, from time signal arrives at PSU)

Trip detection
Controls signal
RF Shutdown
RF signal from pick-up

Total RF-OFF Delay $28.4 \mu s$

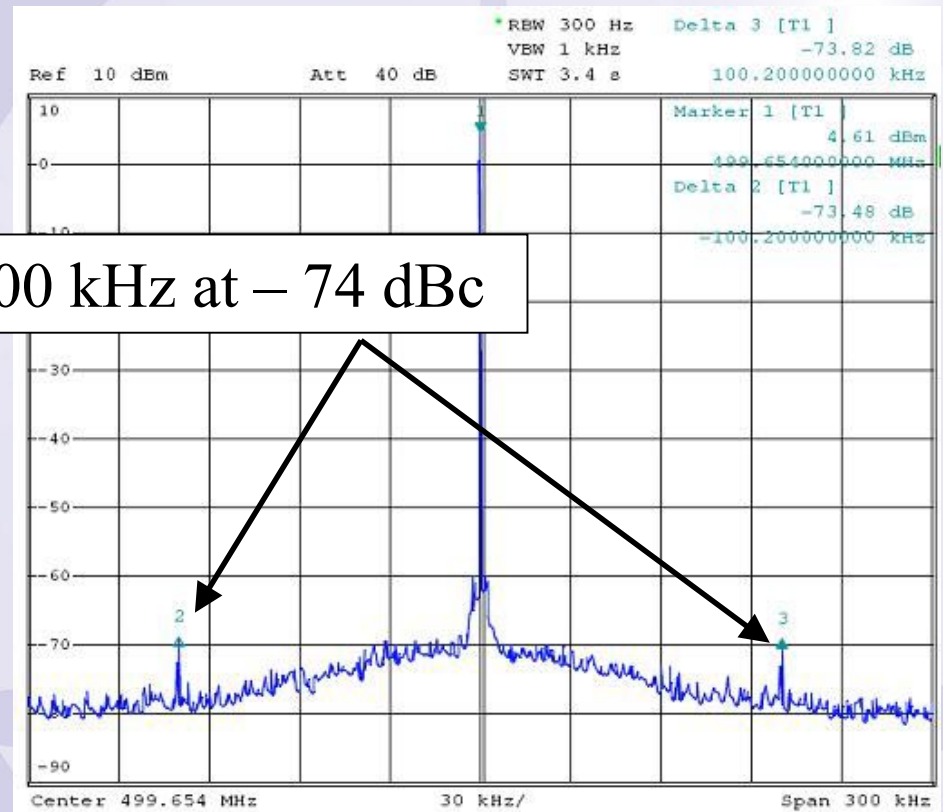
Voltage Ripple

Output Power	Voltage [kV]	Current [A]	Ripple [Vrms]	Accuracy
-	36.1	0.6	5	36.1 (+0.1)
150kW	35.9	8.8	5	35.9 (-0.1)
300kW	35.9	12.6	8.5	35.9 (-0.1)

Phase Noise

@ 1.56 kHz < 70 dBc -
rotational frequency of power
modules

@ 100 kHz < 70 dBc -
switching frequency of power
modules

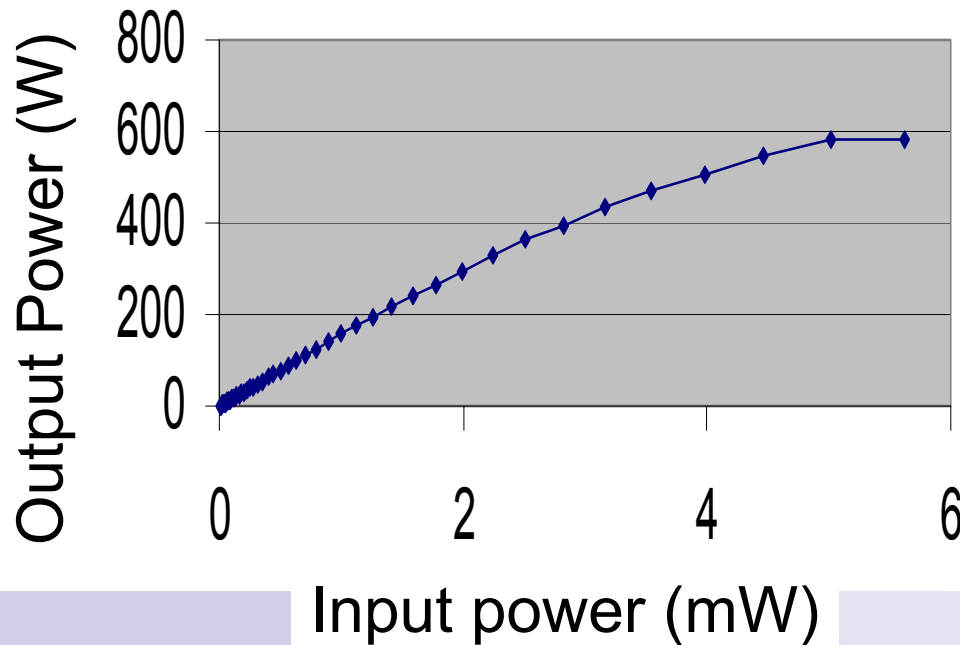
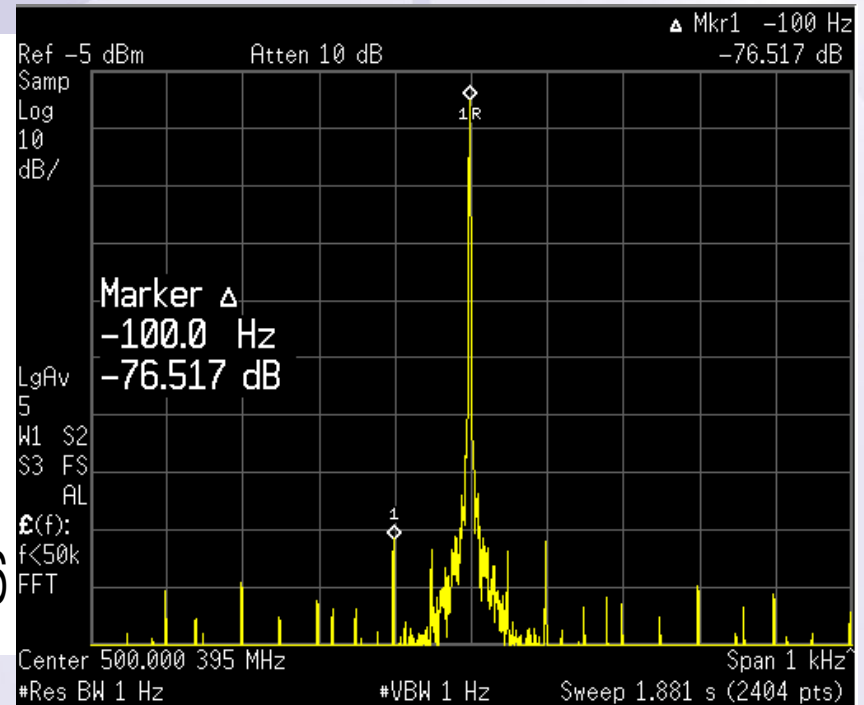
Drive amplifiers

Original drive amplifiers replaced by TH15701 525 W from TED

First 4 delivered and installed. Two further units delivered.
Delivery of remaining units shortly.

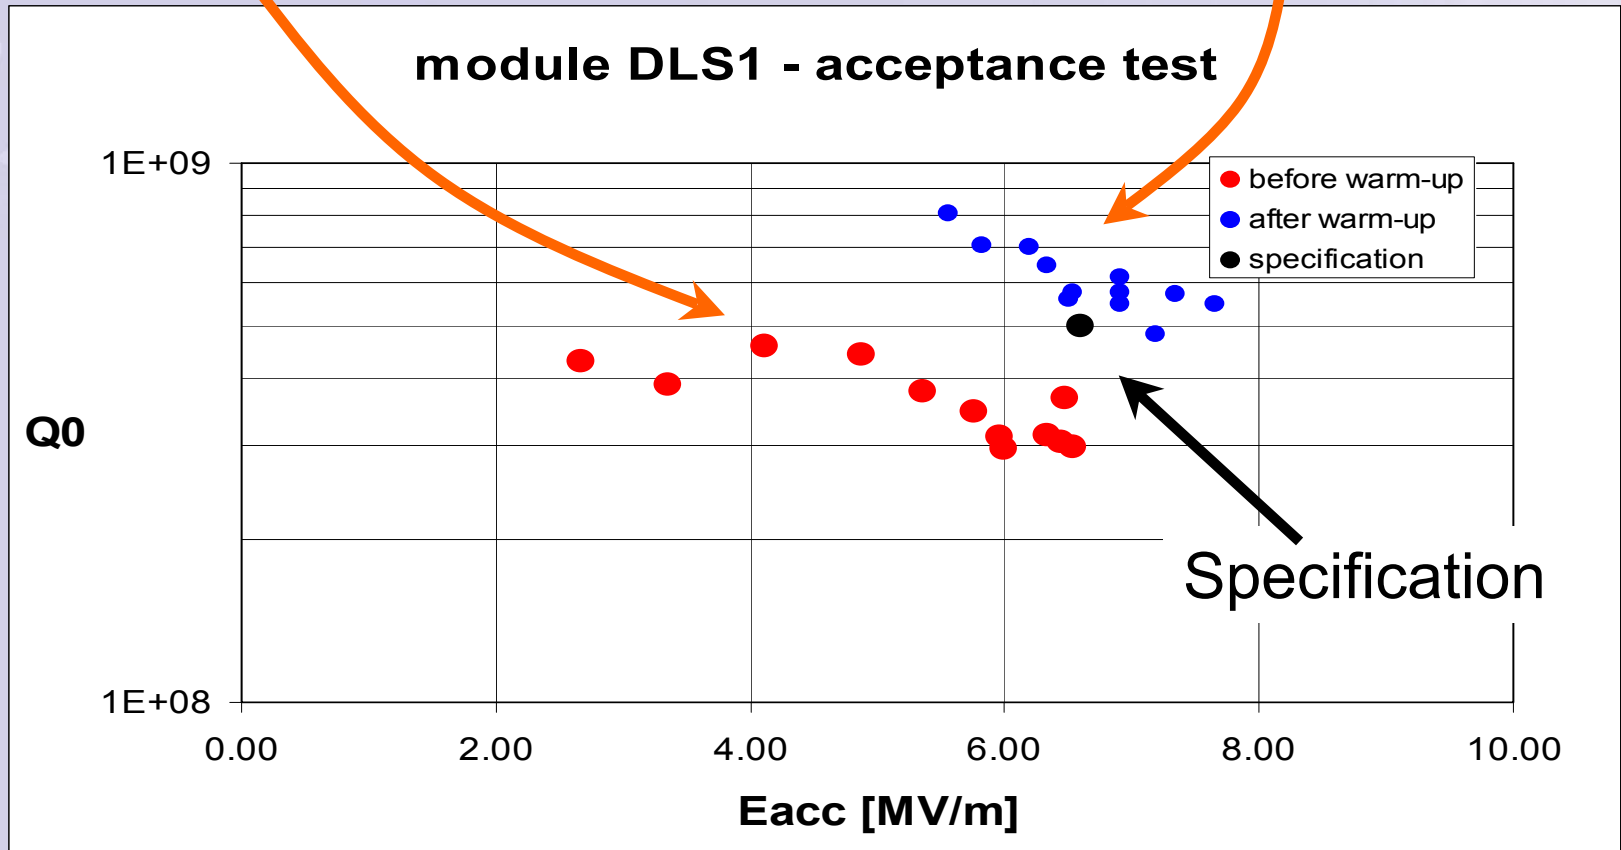
Initially cavity took long to condition and Q_0 was poor

Cavity was warmed up and cooled back down

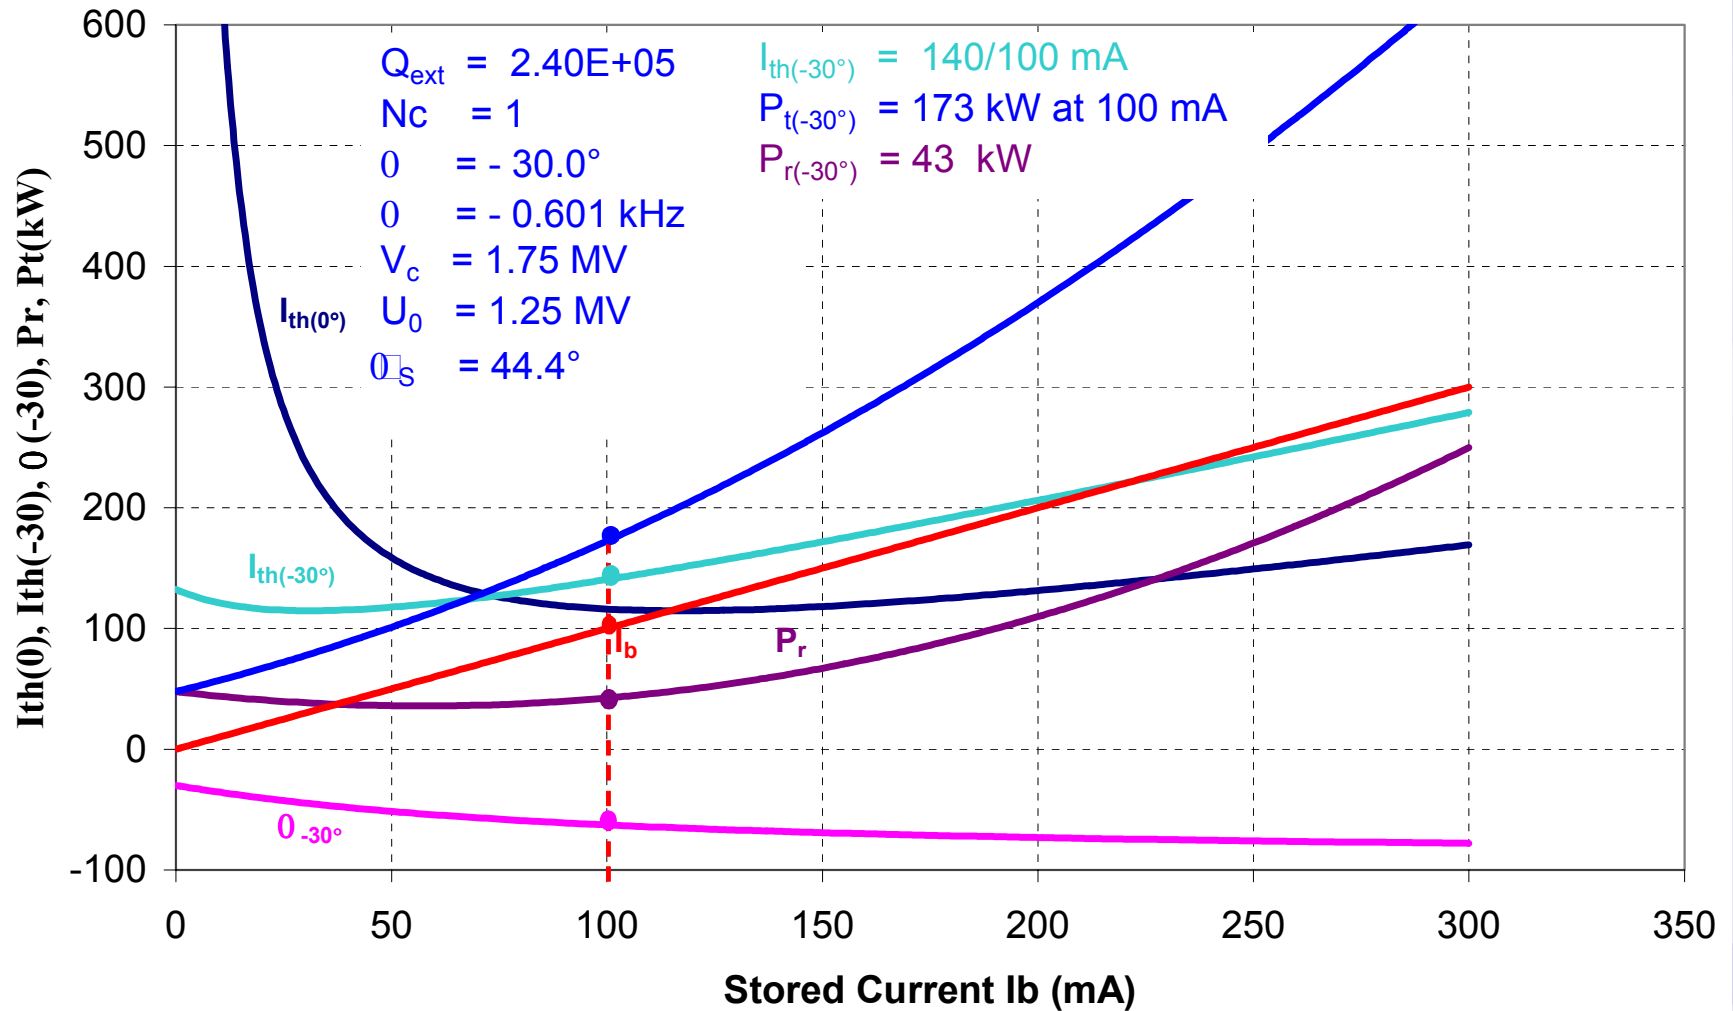
Robinson Stability

Single Cavity Operation

Target current 100 mA

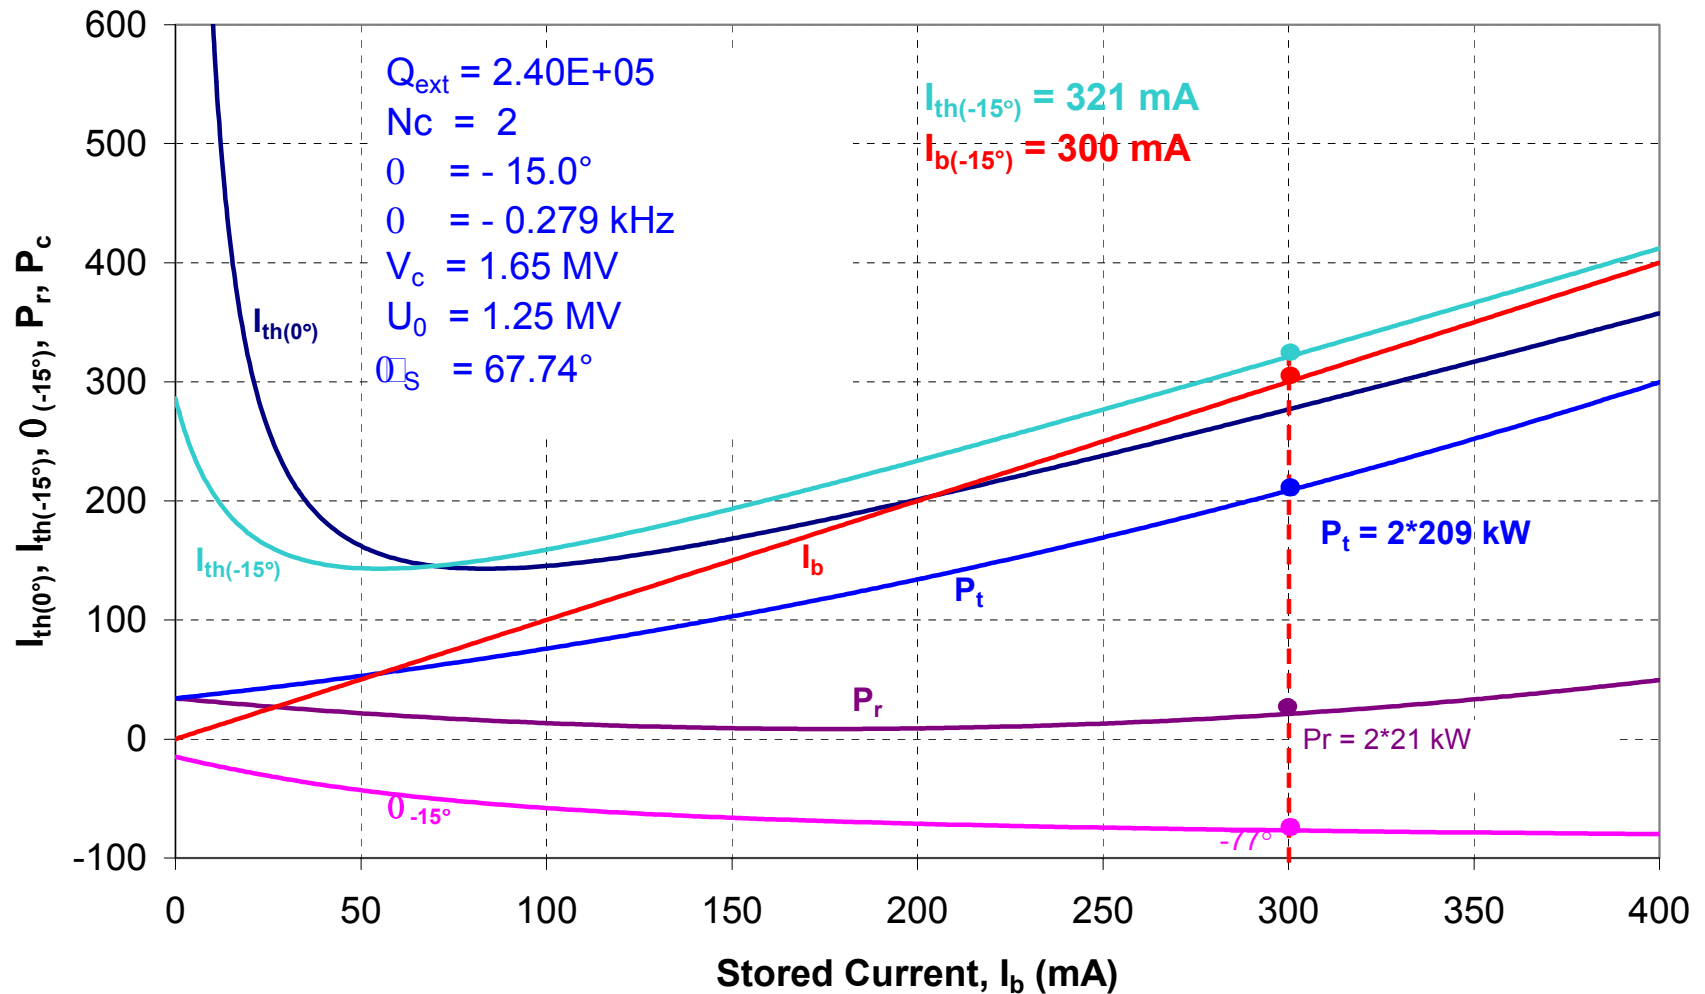
Robinson Stability

Two Cavity Operation

Target current 300 mA

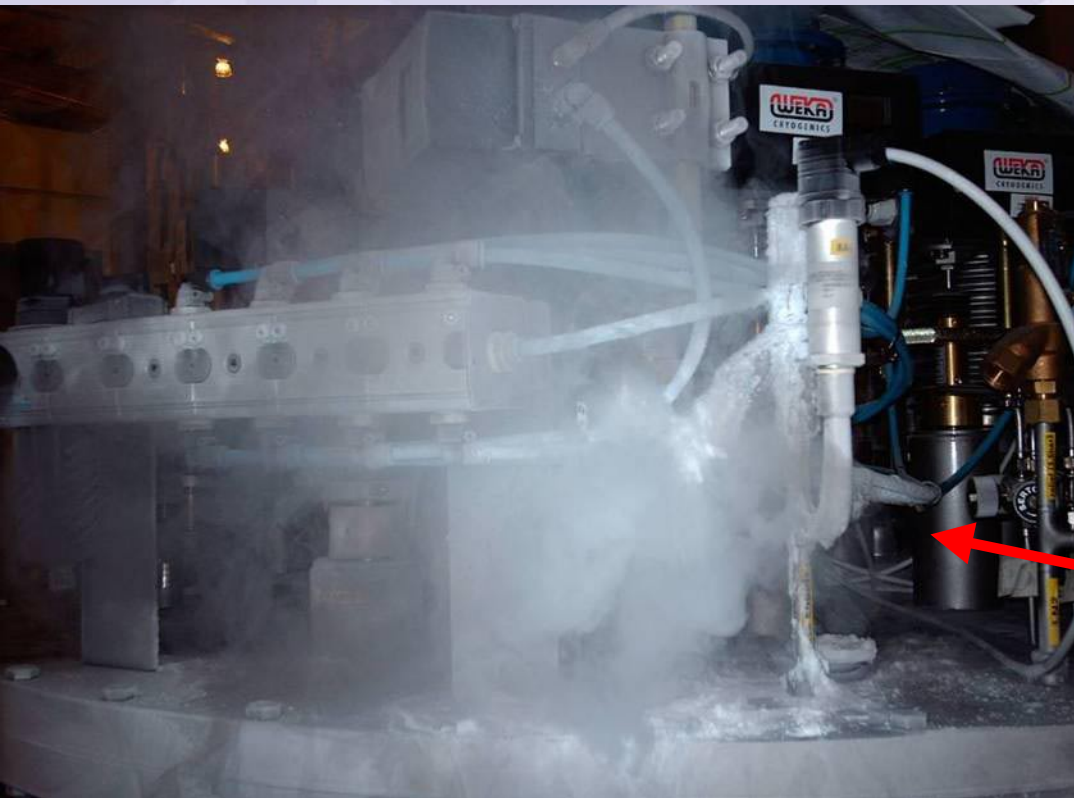
Helium Liquefier

Liquid helium refrigerator refrigeration	488 W (+ 20 L liquefaction)
Liquid helium refrigerator liquefaction	189 L/hr

Cold start is difficult
Compressor PLC replaced
Pressure sensor replaced
Fault with temp. sensor
